## Annual Inspection

Wycombe District Council

The Pedestal Playing Field

Annual Inspection - 05 September 2018 at 14:37 Inspector: Lyn Williams RPII Annual Inspector

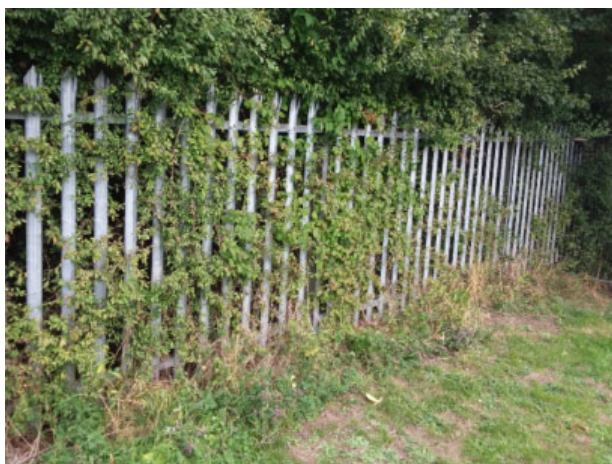
This item is satisfactory - no work required

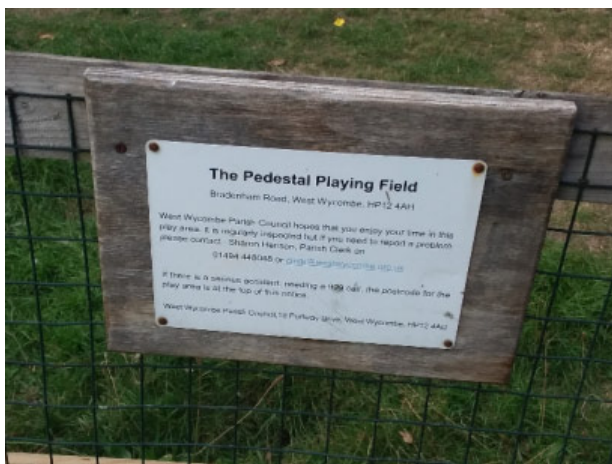
This item is satisfactory - no work required

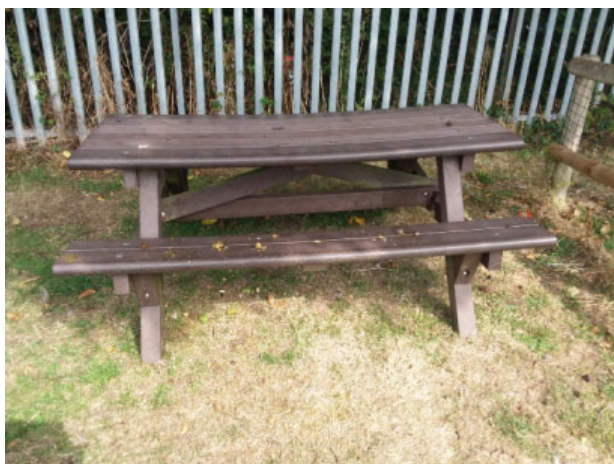
This item is satisfactory - no work required

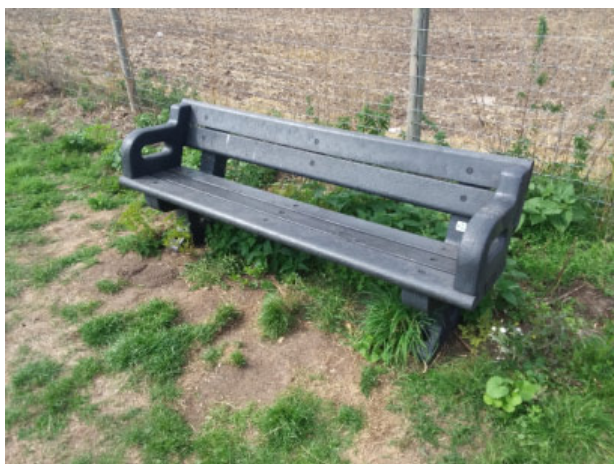
The area around the item has eroded and may become slippery - Reinstate eroded area

<b>Finding:</b>	The area around the item has eroded and may become slippery		<b>Action:</b> Reinstate eroded area

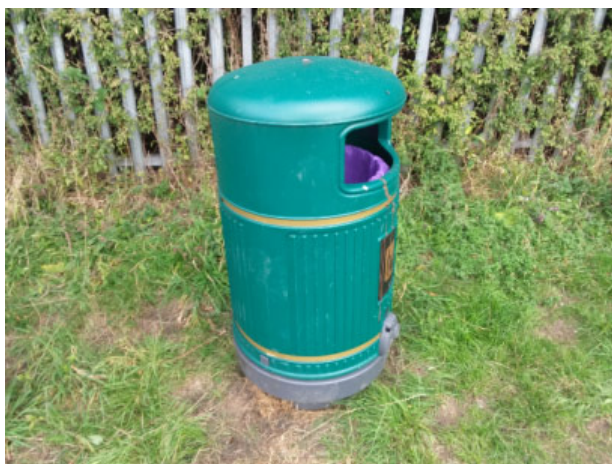
This item is satisfactory - no work required

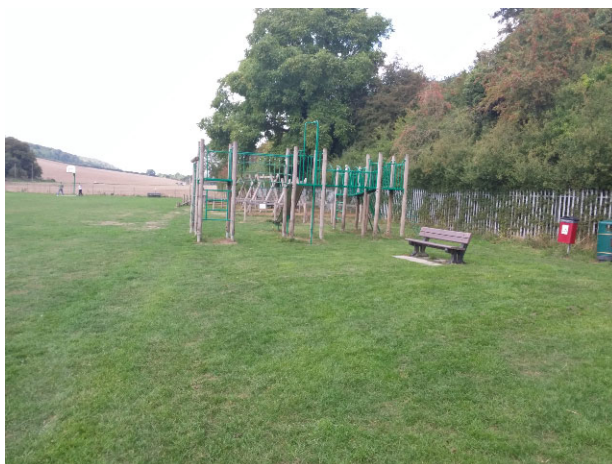
The grass mats are silted up and the soil is compacted; this may have an effect on the impact absorbing properties of the surface - Consider HIC testing impact absorbing properties to ensure the correct surface qualities are maintained for the equipment and replace as required

All timber posts have a number of splits/shakes or air cracks and this may affect the stability or allow water ingress which will accelerate the rotting process - Monitor to ensure the splits do not cross through fixing points of the structure and/or cause any instability

There is some strimmer / machinery damage apparent on the posts, this can penetrate the preservative applied to the timber and accelerate the rotting process - Monitor for any deterioration (rot) and replace as required

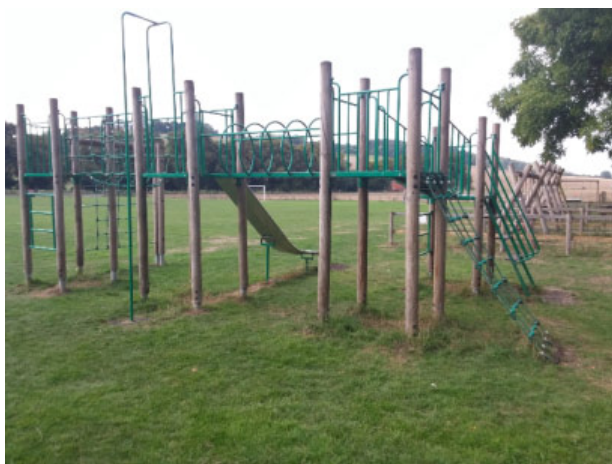
The height of the slide runout is in excess of 350mm and fails the requirements of BS EN 1176: Part 3 - Monitor use

The side of the slide extends less than 500mm above the slide surface at the start section - Monitor use

Parts of the timber are rough or splintered - Remove all rough or sharp edges

The timber platform is rough and worn - Sand down and treat affected areas

The connecting links are in excess of 8.6mm and less than 12mm and fail the requirements of BS EN 1176 Part 1; clause 4.2.13, Chains - Monitor use and replace with compliant links at the next maintenance cycle

There is surface corrosion present on the shackles - Consider treating and repainting the item

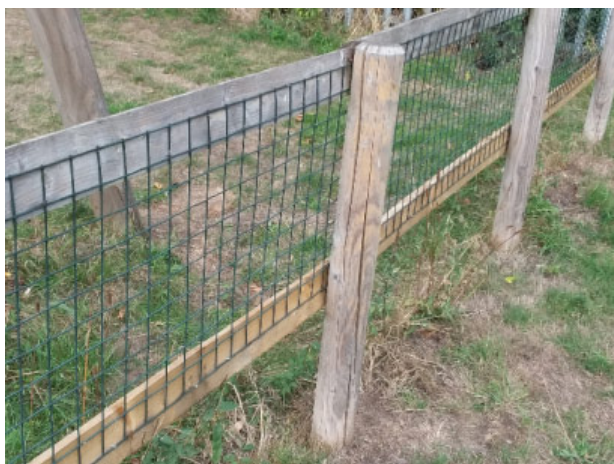
There is some evidence of rot in the timber - Monitor for any further deterioration and replace as required

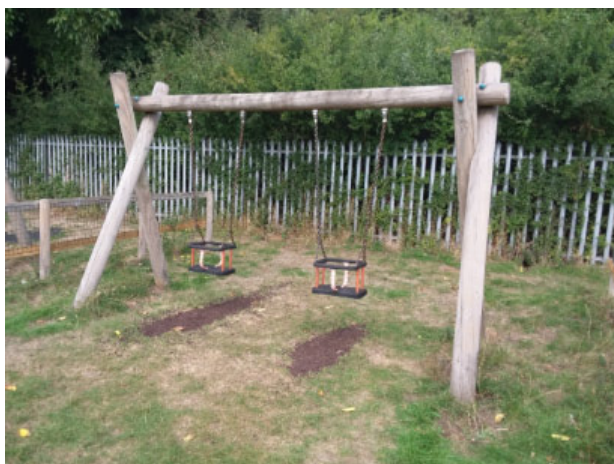
There are caps missing from the underside of the seats - Replace missing caps under the seats

The chain openings are in excess of the 8.6mm as recommended by BS EN 1176 - Monitor use

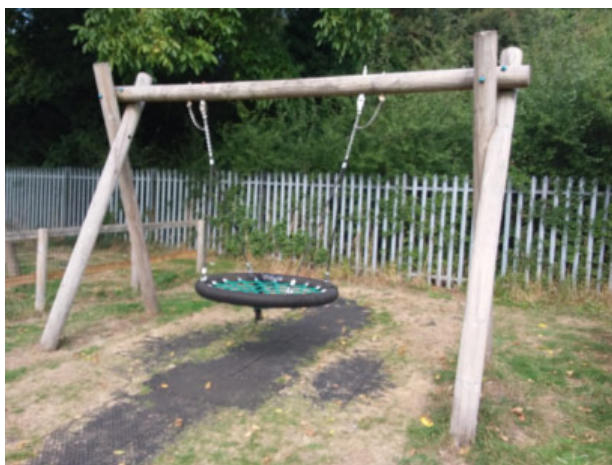
There are gaps opening between the grass mat tiles - Reinstate surface

There are areas or parts of the timber on the structure that have rotted - Replace all affected timbers

The rope has worn on the basket - Replace rope or net

The connecting links are in excess of 8.6mm and less than 12mm and fail the requirements of BS EN 1176 Part 1; clause 4.2.13, Chains - Monitor use and replace with compliant links at the next maintenance cycle

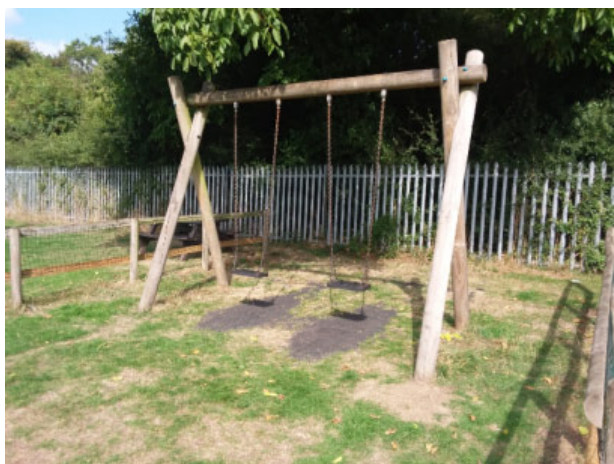
The tree canopy overhangs the equipment and is less than 2.0m away - Lift tree canopy to ensure a minimum clearance of 2.0m from the equipment

The connecting links are in excess of 8.6mm and less than 12mm and fail the requirements of BS EN 1176 Part 1; clause 4.2.13, Chains - Monitor use and replace with compliant links at the next maintenance cycle

There are gaps opening between the grass mat tiles - Reinstate surface

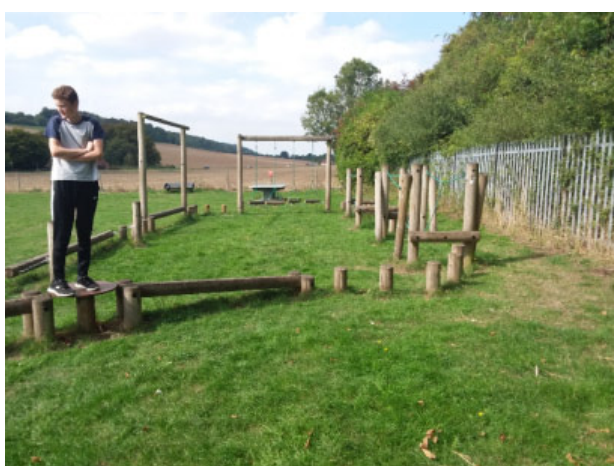
The connecting links are in excess of 8.6mm and less than 12mm and fail the requirements of BS EN 1176 Part 1; clause 4.2.13, Chains - Monitor use and replace with compliant links at the next maintenance cycle

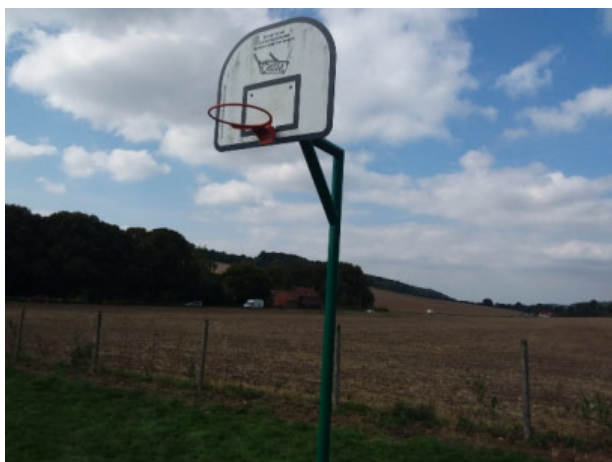
This item is satisfactory - no work required

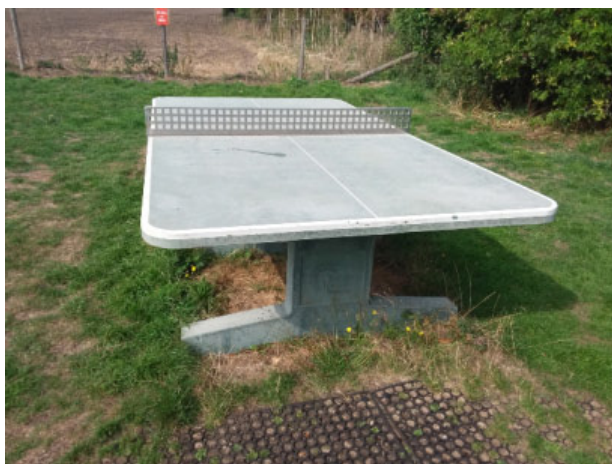
This item is satisfactory - no work required

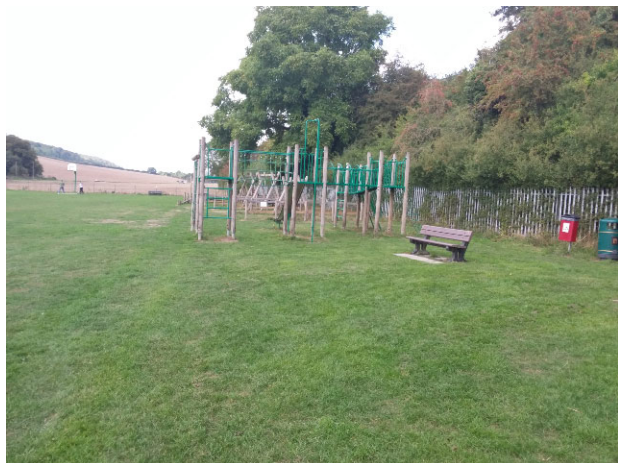
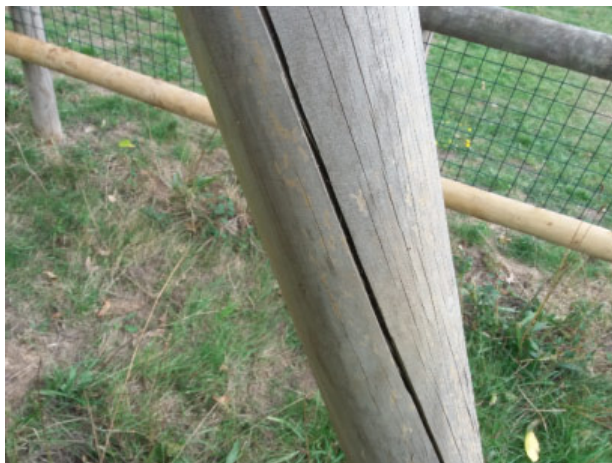
**Finding:** All timber posts have a number of splits/shakes or air cracks and this may affect the stability or allow water ingress which will accelerate the rotting process

**Action:** Monitor to ensure the splits do not cross through fixing points of the structure and/or cause any instability

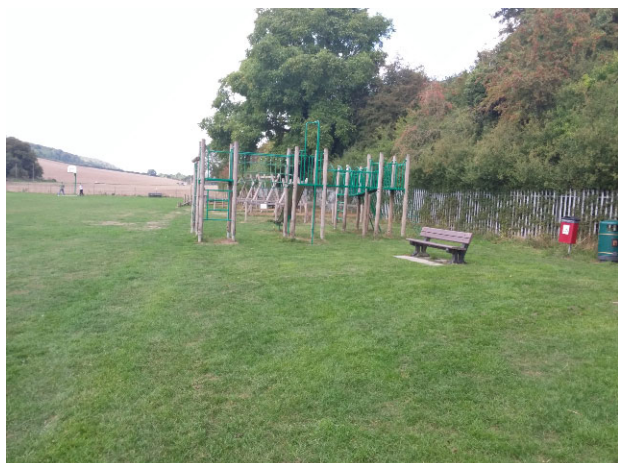
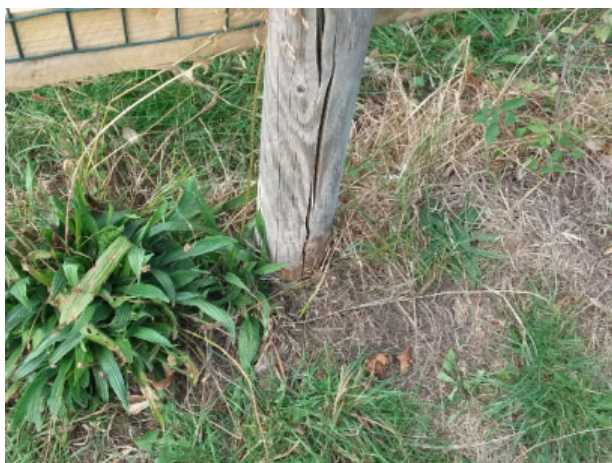
**Finding:** There is some strimmer / machinery damage apparent on the posts, this can penetrate the preservative applied to the timber and accelerate the rotting process

**Action:** Monitor for any deterioration (rot) and replace as required

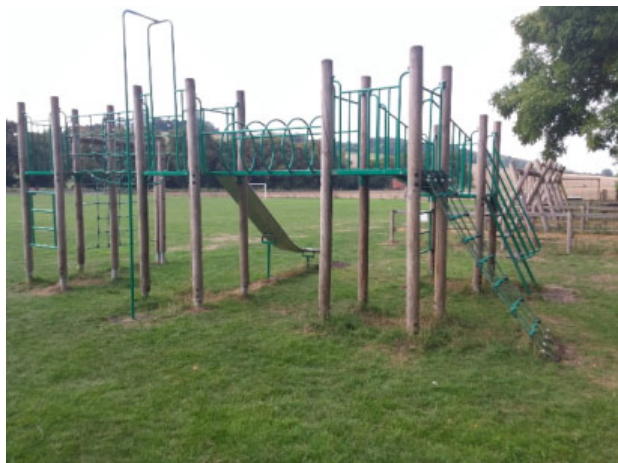
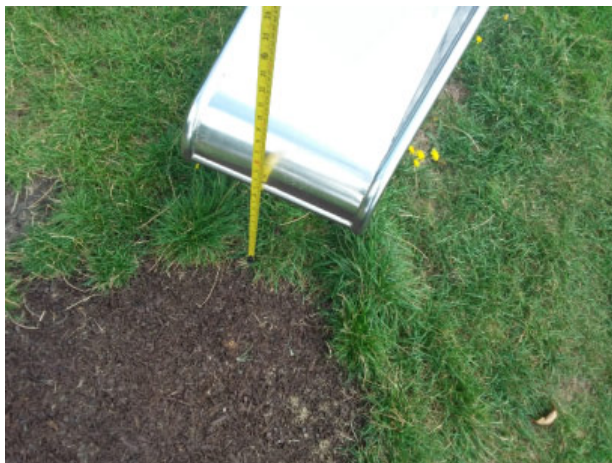
**Finding:** The height of the slide runout is in excess of 350mm and fails the requirements of BS EN 1176: Part 3

**Action:** Monitor use

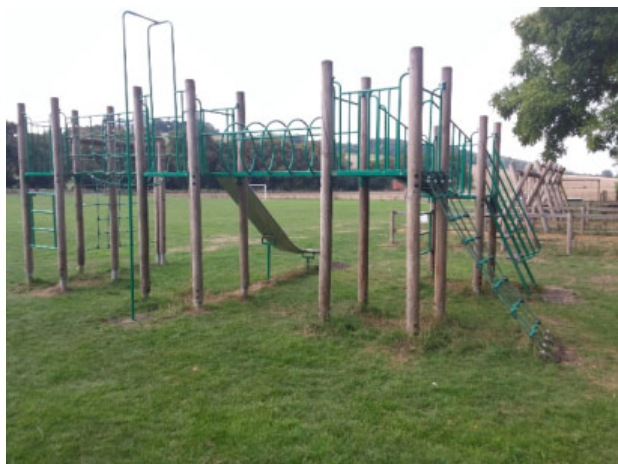
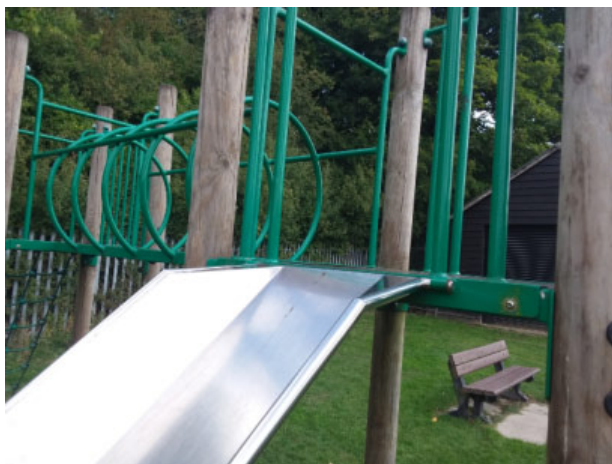
**Finding:** The side of the slide extends less than 500mm above the slide surface at the start section

**Action:** Monitor use

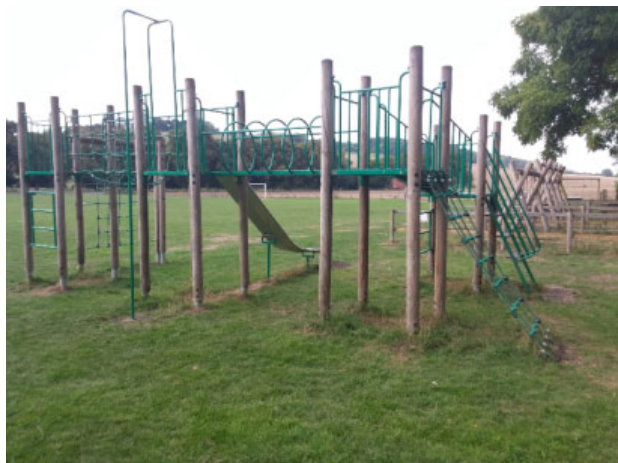
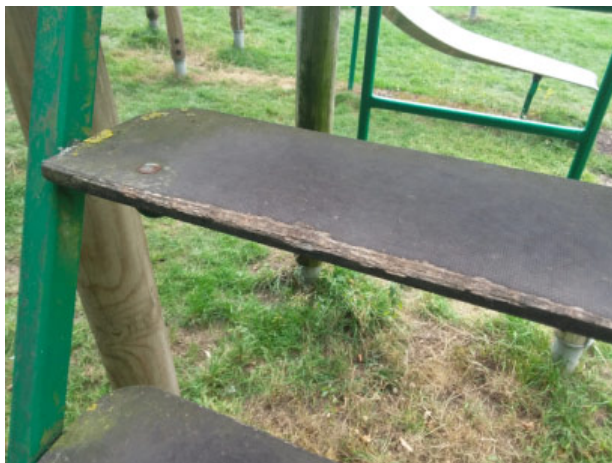
**Finding:** Parts of the timber are rough or splintered

**Action:** Remove all rough or sharp edges

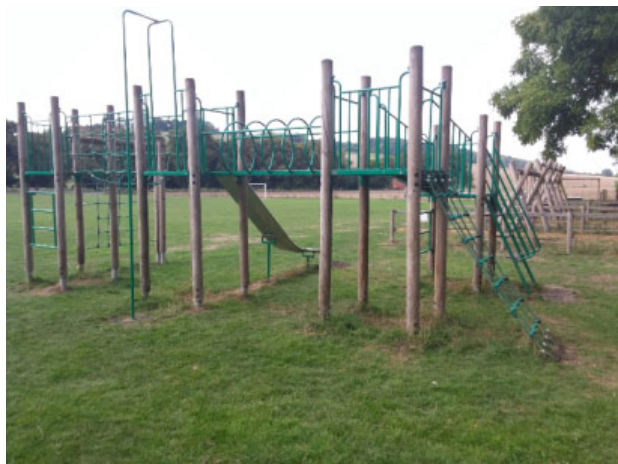
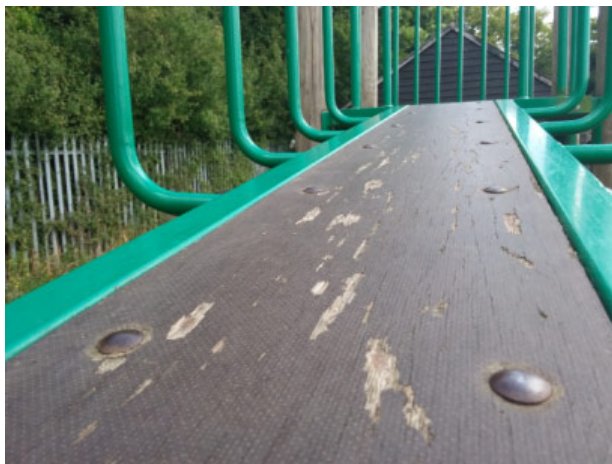
**Finding:** The timber platform is rough and worn

**Action:** Sand down and treat affected areas

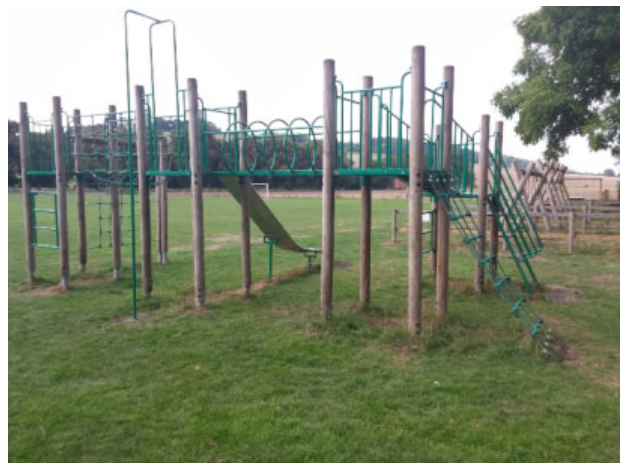
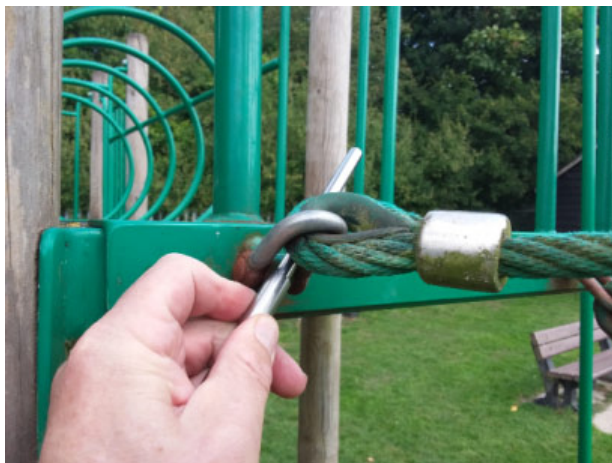
**Finding:** The connecting links are in excess of 8.6mm and less than 12mm and fail the requirements of BS EN 1176 Part 1; clause 4.2.13, Chains

**Action:** Monitor use and replace with compliant links at the next maintenance cycle

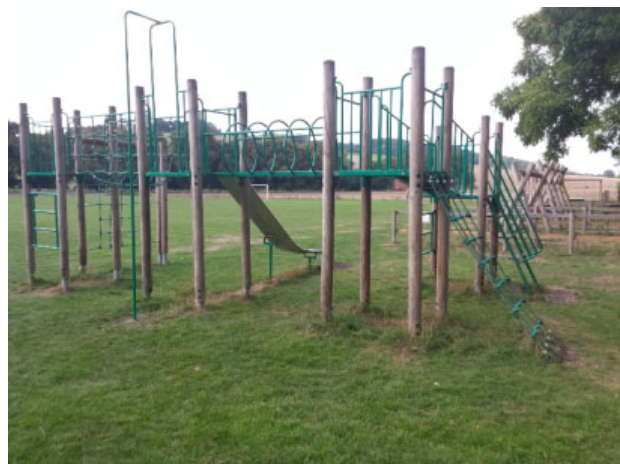
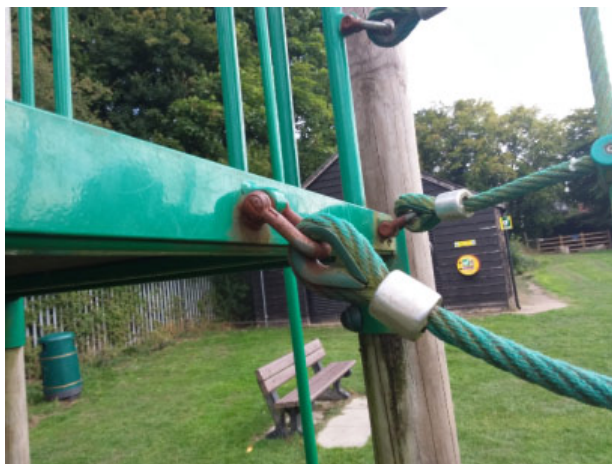
**Finding:** There is surface corrosion present on the shackles

**Action:** Consider treating and repainting the item

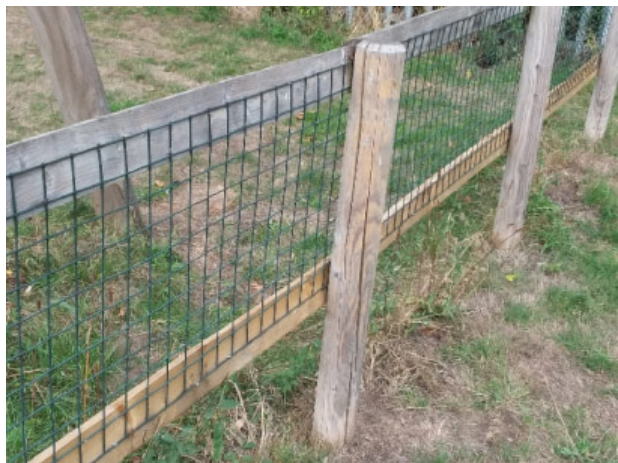
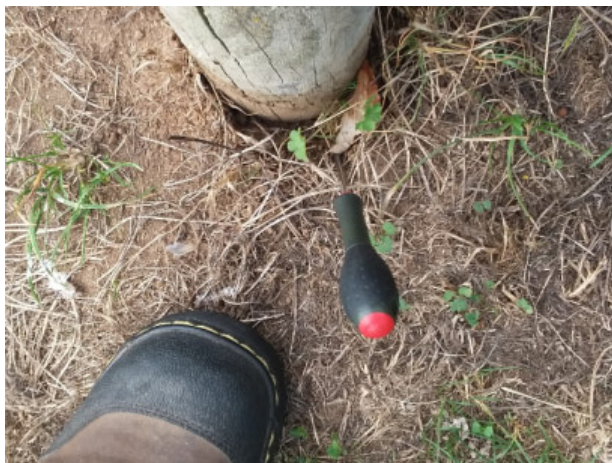
**Finding:** There is some evidence of rot in the timber

**Action:** Monitor for any further deterioration and replace as required

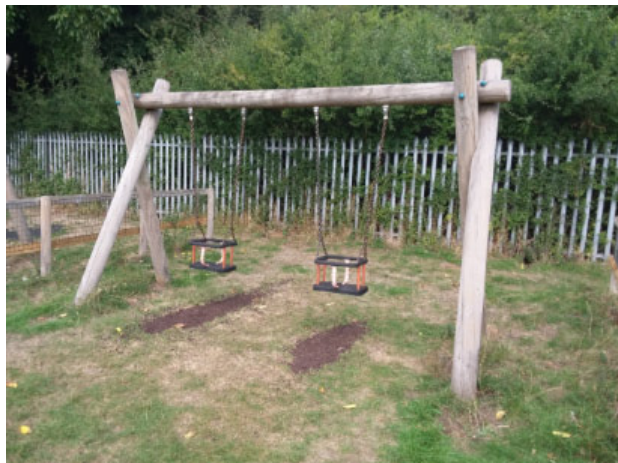
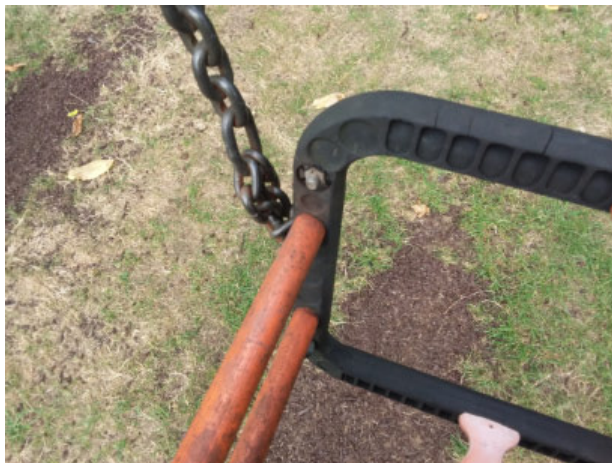
**Finding:** There are caps missing from the underside of the seats

**Action:** Replace missing caps under the seats

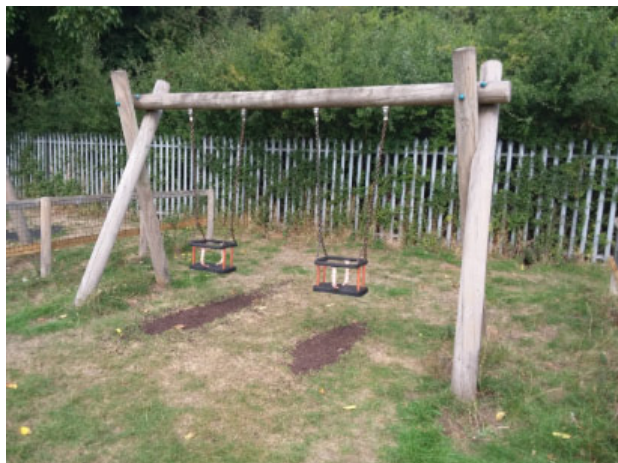
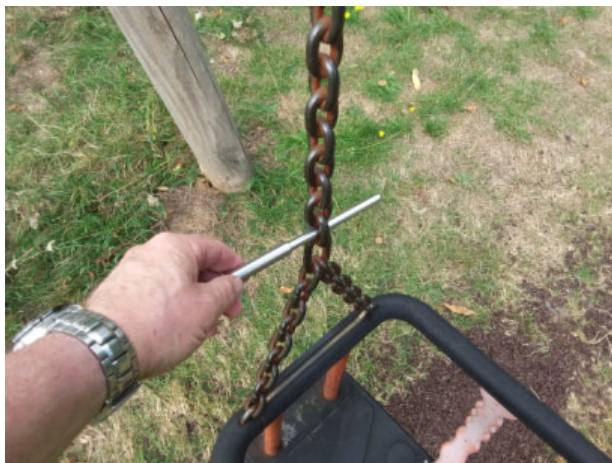
**Finding:** The chain openings are in excess of the 8.6mm as recommended by BS EN 1176

**Action:** Monitor use

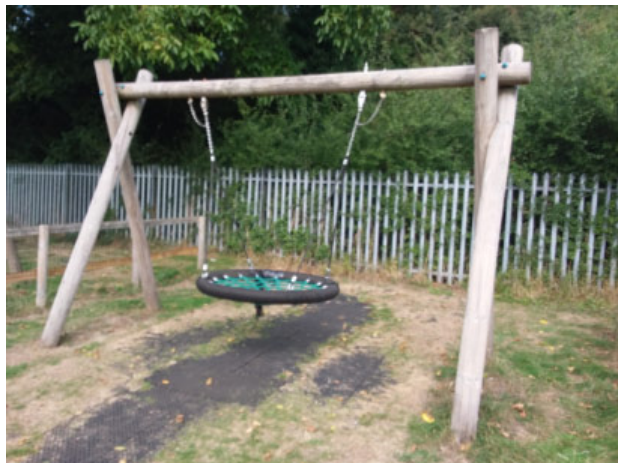
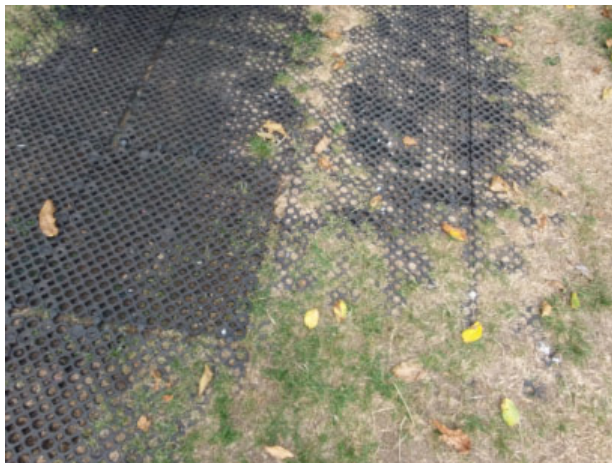
**Finding:** There are gaps opening between the grass mat tiles

**Action:** Reinstate surface

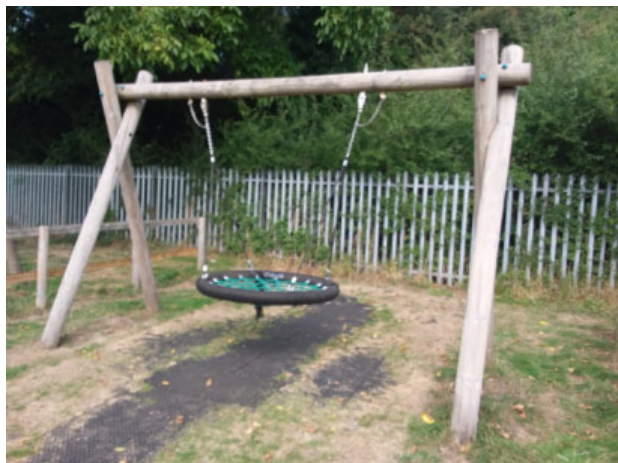
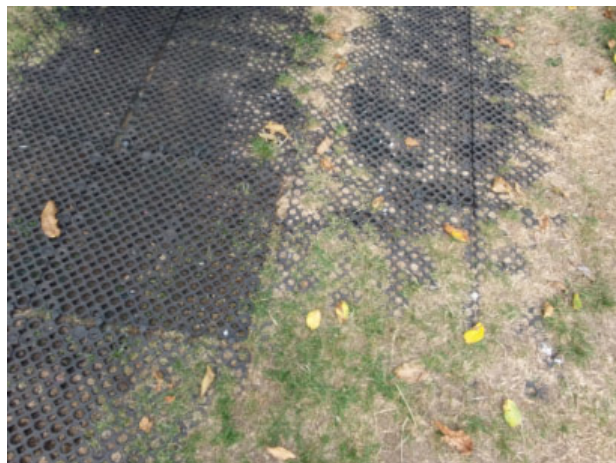
**Finding:** There are gaps opening between the grass mat tiles

**Action:** Reinststate surface

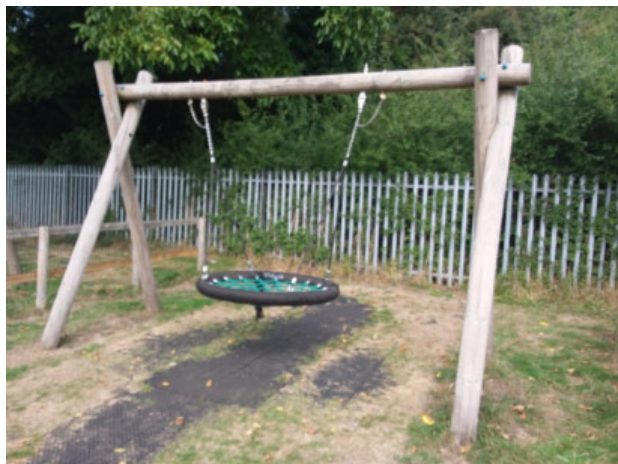
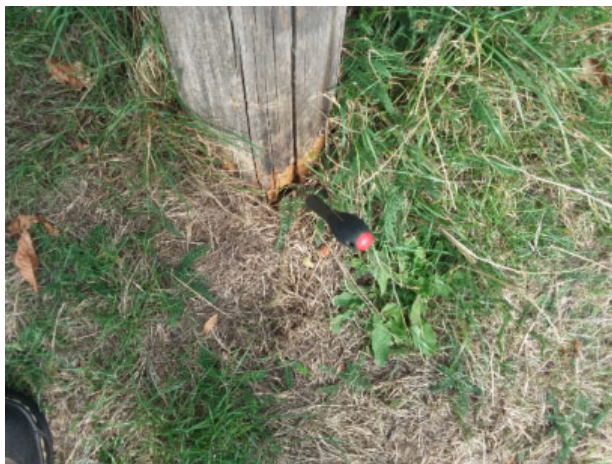
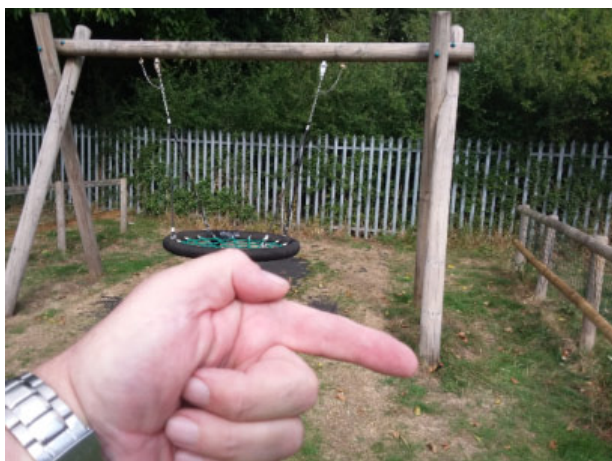
**Finding:** There are areas or parts of the timber on the structure that have rotted

**Action:** Replace all affected timbers

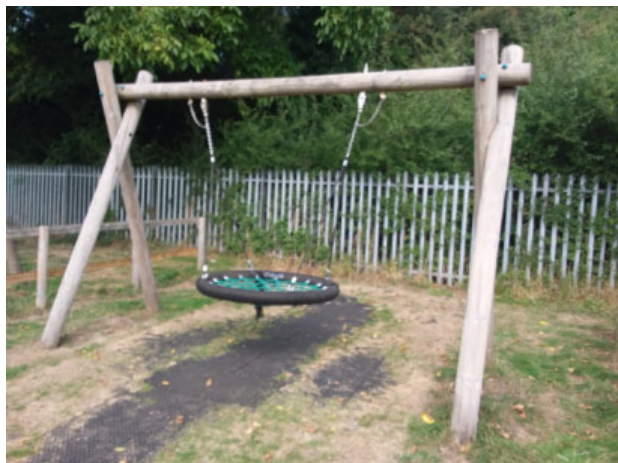
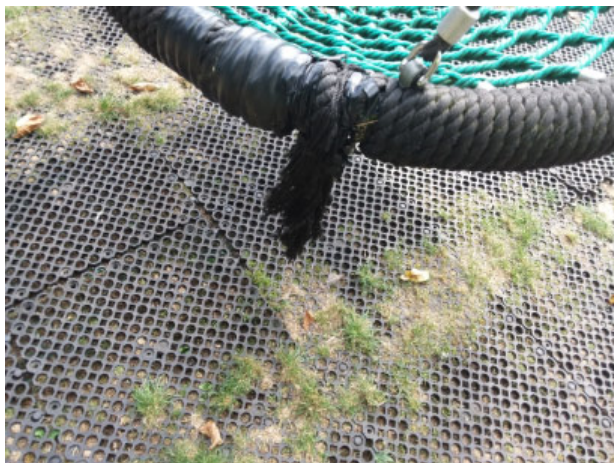
**Finding:** The rope has worn on the basket

**Action:** Replace rope or net

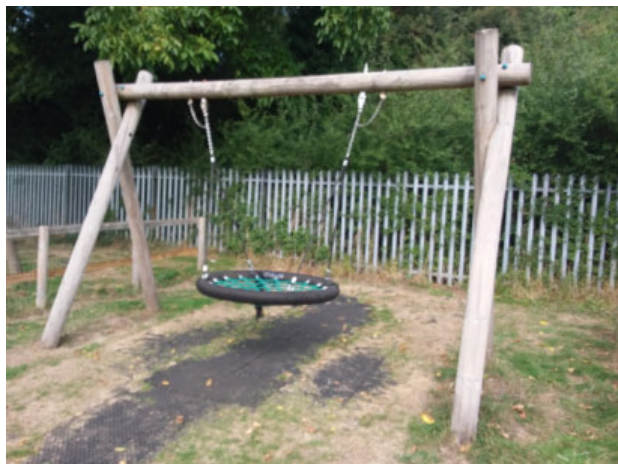
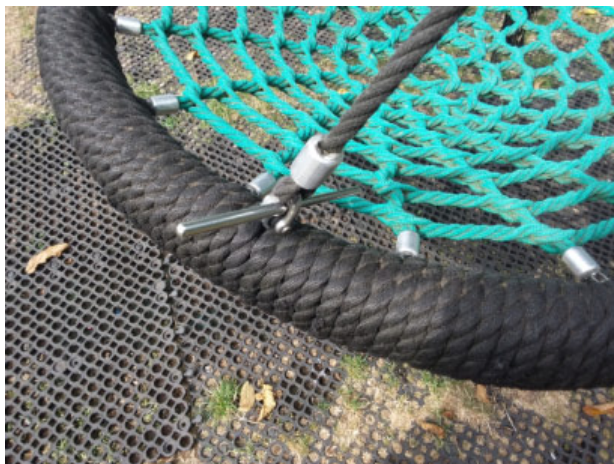
**Finding:** The connecting links are in excess of 8.6mm and less than 12mm and fail the requirements of BS EN 1176 Part 1; clause 4.2.13, Chains

**Action:** Monitor use and replace with compliant links at the next maintenance cycle

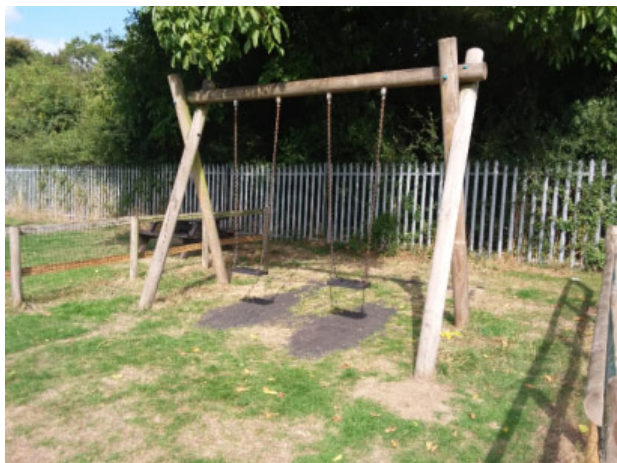
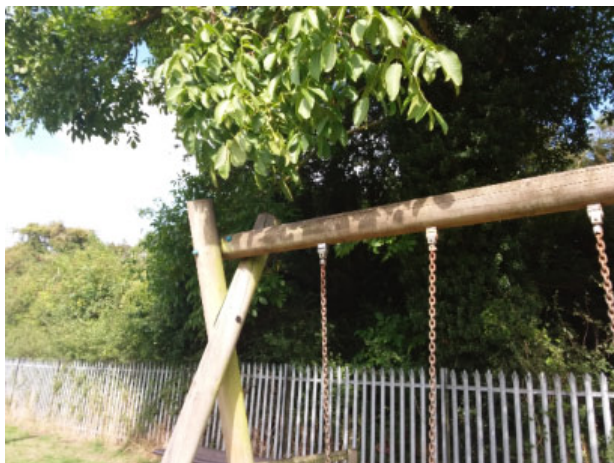
**Finding:** The tree canopy overhangs the equipment and is less than 2.0m away

**Action:** Lift tree canopy to ensure a minimum clearance of 2.0m from the equipment

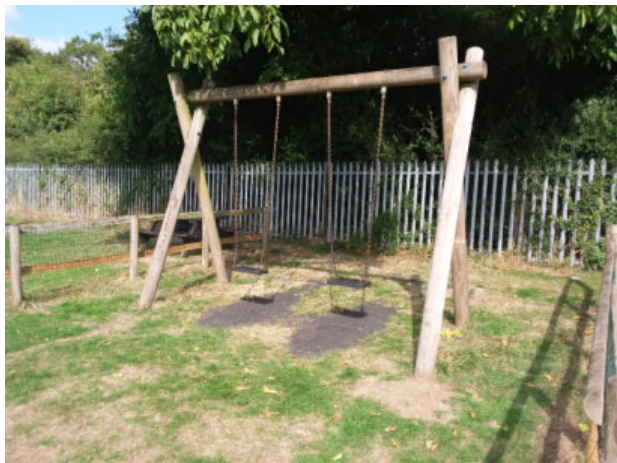
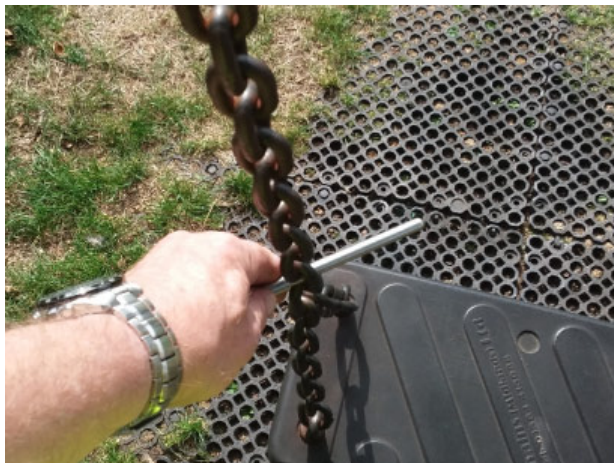
**Finding:** The connecting links are in excess of 8.6mm and less than 12mm and fail the requirements of BS EN 1176 Part 1; clause 4.2.13, Chains

**Action:** Monitor use and replace with compliant links at the next maintenance cycle

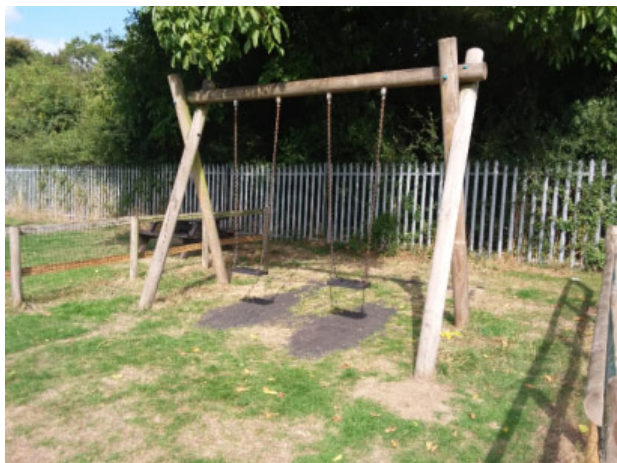
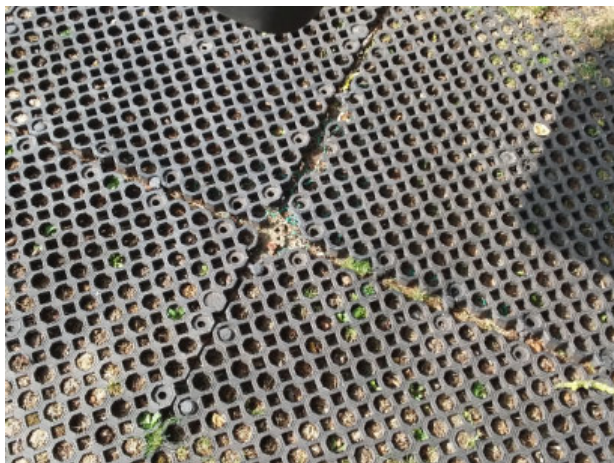
**Finding:** There are gaps opening between the grass mat tiles

**Action:** Reinstate surface

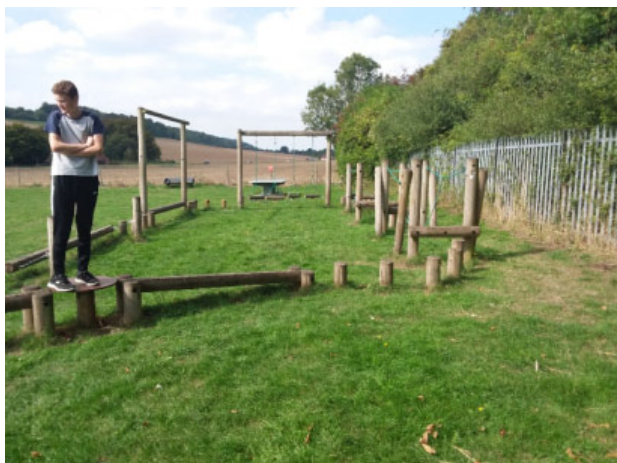
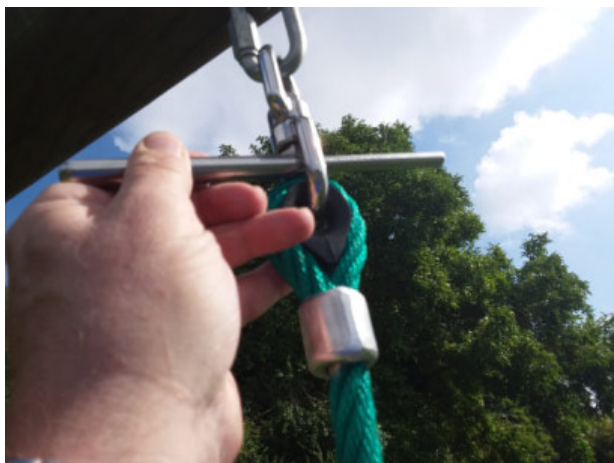
**Finding:** The connecting links are in excess of 8.6mm and less than 12mm and fail the requirements of BS EN 1176 Part 1; clause 4.2.13, Chains

**Action:** Monitor use and replace with compliant links at the next maintenance cycle
