# **Annual Inspection**

**Wycombe District Council**

The Pedestal Playing Field

Cookshall Lane, off Bradenham Road, West Wycombe, Buckinghamshire, HP12 4AH

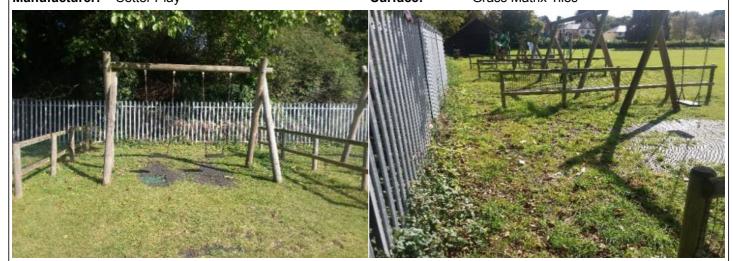
# 6 - Low Risk (Finding 2)

Item: Swings - 1 Bay 2 Seat (Flat) Risk Level: L - Low Risk Manufacturer: Setter Play **Grass Matrix Tiles** Surface:

Finding: The edge of the impact area is less than 1.5m from Action: Monitor - No remedial work recommended the fence; BS EN 1176, Annexe A; we consider this to be a low risk finding and no remedial action is required

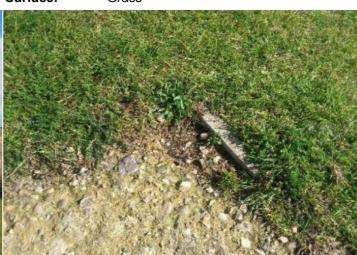
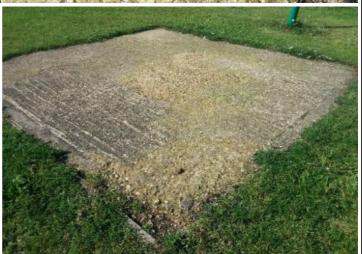
Multi Use Games Area - Basketball Post Risk Level: L - Low Risk Item: Manufacturer: Safe & Sound Surface: Grass

Finding: The surface is worn or damaged

Action: Repair the to provide a uniform surface
