the **play inspection** company

Annual Inspection

The Pedestal Playing Field

Inspection Ref: 1188591

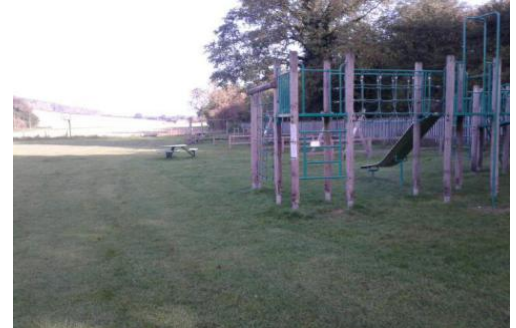
The site is accessible to the public during the COVID 19 pandemic. The government have released guidelines for safely re-opening these types of facilities which is available on the government website. - Ensure there is an appropriate risk assessment in place and review regularly

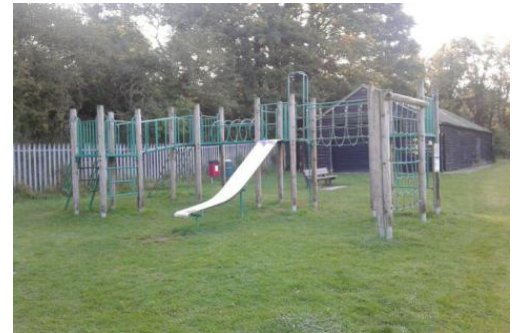
The height of the slide runout is in excess of 350mm and fails the requirements of BS EN 1176: Part 3 - Monitor - No remedial work recommended

The connecting links are in excess of 8.6mm and less than 12mm and fail the requirements of BS EN 1176 Part 1; clause 4.2.13, Chains - Monitor - No remedial work recommended

There is/are finger entrapment/s in the frame and the item fails to meet the requirements of BS EN 1176 Part 1 4.2.7.6 Entrapment of fingers - Monitor - No remedial work recommended

The shackle has some corrosion - Monitor for any further deterioration and replace as required

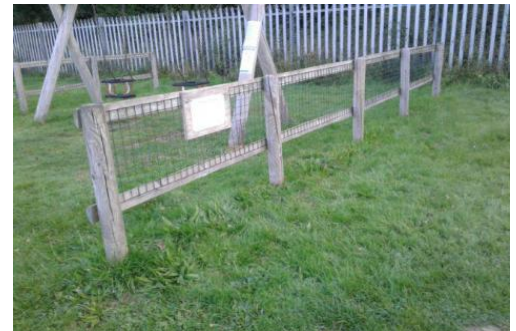
The mesh has been damaged and sharp wires are protruding - Repair or replace the item

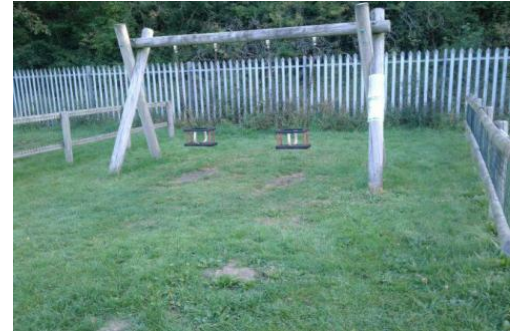
This design of swing joint has been known to fail on the weld connecting the joint to the threaded stud - We would recommend that the joint be dismantled and checked on a regular basis or a Secondary Safety Device be fitted

The swing seat frames are corroding - Monitor for any further deterioration and replace as required

There are caps missing from the underside of the seats -
Replace missing caps under the seats

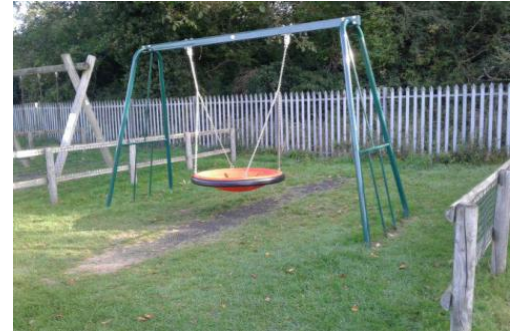
The surfacing around the item is damaged - Repair the damaged areas of surfacing

There are gaps opening between the grass mat tiles - Reinstall surface

Swings of this design should have a secondary safety device fitted to prevent collapse of the seat in the event of a joint failure to meet the requirements of BS EN 1176 Part 2 - Consider providing a secondary safety device where possible

The edge of the impact area is less than 1.5m from the fence; BS EN 1176, Annexe A; we consider this to be a low risk finding and no remedial action is required - Monitor - No remedial work recommended

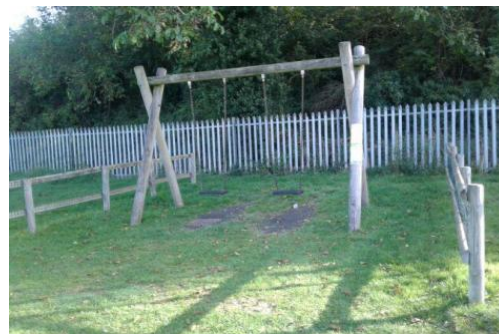
The surfacing around the item is damaged - Repair the damaged areas of surfacing

There is some notable evidence of chain wear - Monitor for any further deterioration and replace when 40% worn

The connecting links are in excess of 8.6mm and less than 12mm and fail the requirements of BS EN 1176 Part 1; clause 4.2.13, Chains - Monitor - No remedial work recommended

The edge of the impact area is less than 1.5m from the fence; BS EN 1176, Annexe A; we consider this to be a low risk finding and no remedial action is required - Monitor - No remedial work recommended

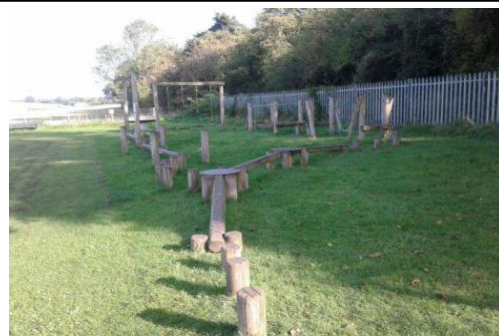
There is algae or moss on the surface of the equipment - Clean and treat appropriately

The ropes/nets are worn/damaged in places - Monitor for any further deterioration and repair or replace as required

The bearing is not operating correctly - Repair or replace the bearing as required

The timber has a number of splits/shakes or air cracks and this may affect the stability or allow water ingress which will accelerate the rotting process - Monitor to ensure the splits do not cross through fixing points of the structure and/or cause any instability

There is/are bolt cap covers missing or damaged on the item - Replace missing or damaged bolt cap covers

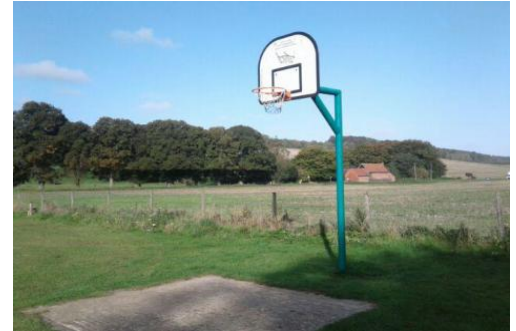
The concrete is showing signs of wear - Monitor for any further deterioration and repair as required

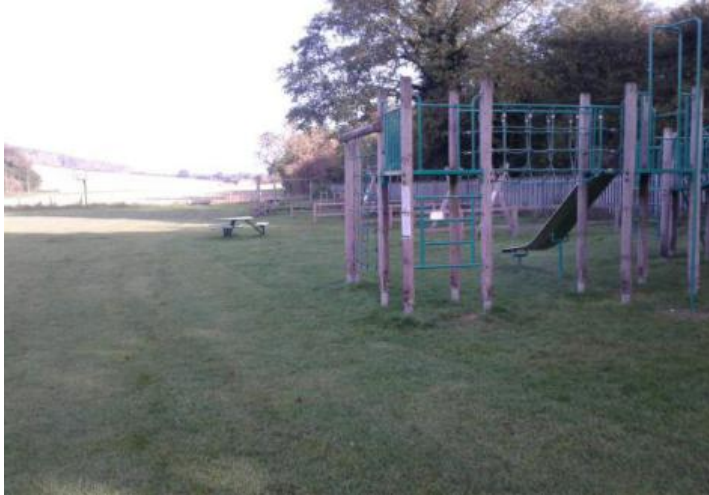
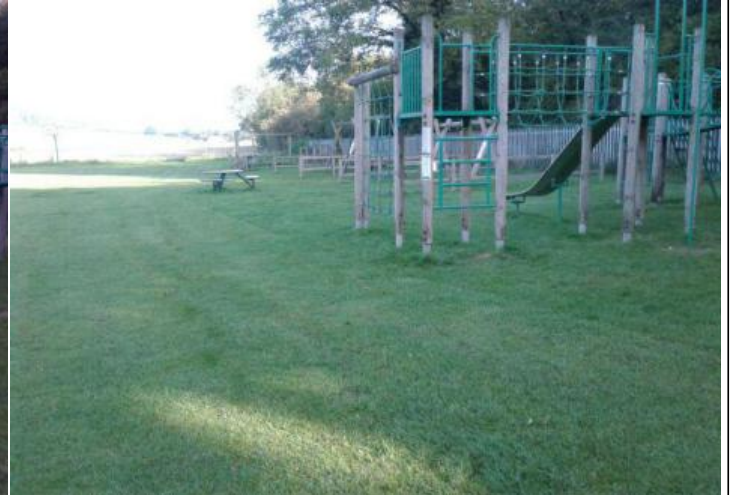
Finding: The site is accessible to the public during the COVID 19 pandemic. The government have released guidelines for safely re-opening these types of facilities which is available on the government website.

Action: Ensure there is an appropriate risk assessment in place and review regularly

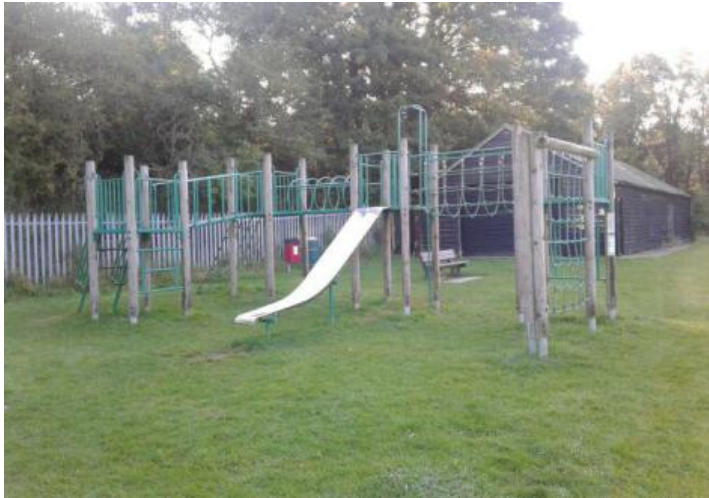
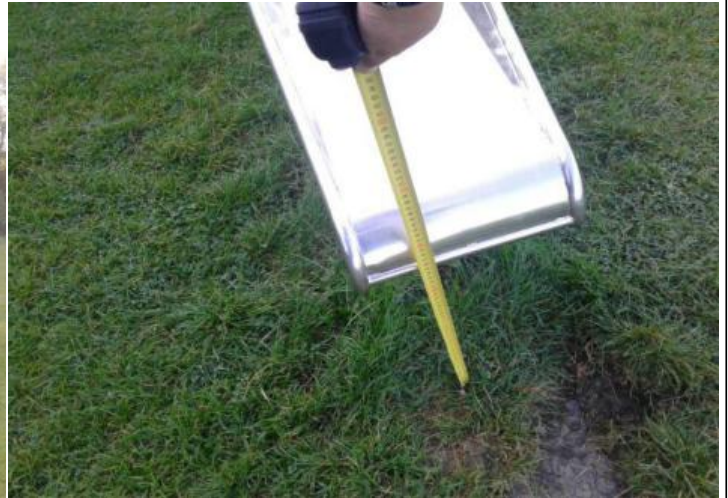
Finding: The height of the slide runout is in excess of 350mm and fails the requirements of BS EN 1176: Part 3

Action: Monitor - No remedial work recommended

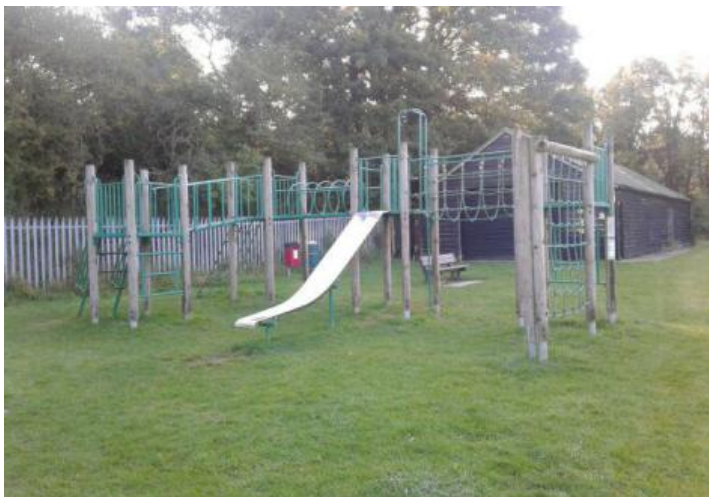
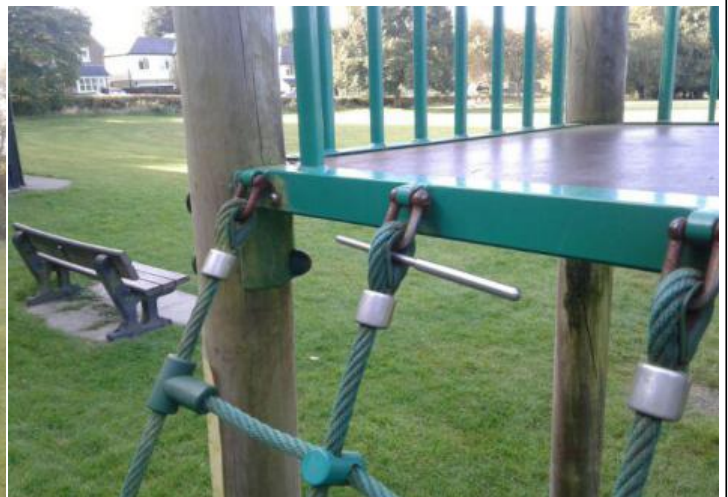
Finding: The connecting links are in excess of 8.6mm and less than 12mm and fail the requirements of BS EN 1176 Part 1; clause 4.2.13, Chains

Action: Monitor - No remedial work recommended

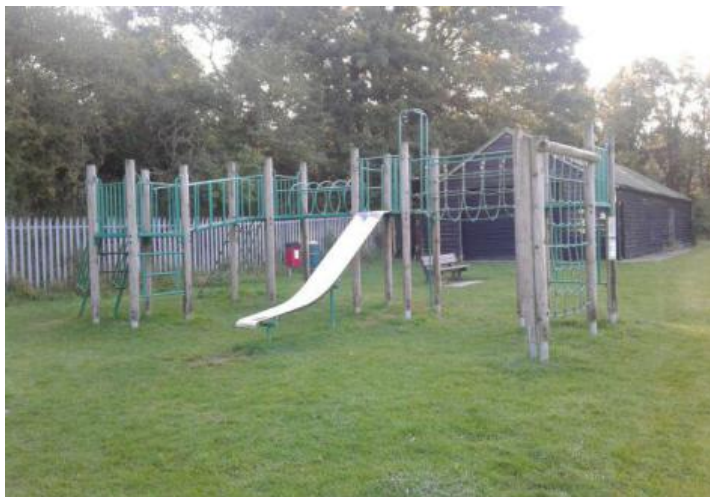
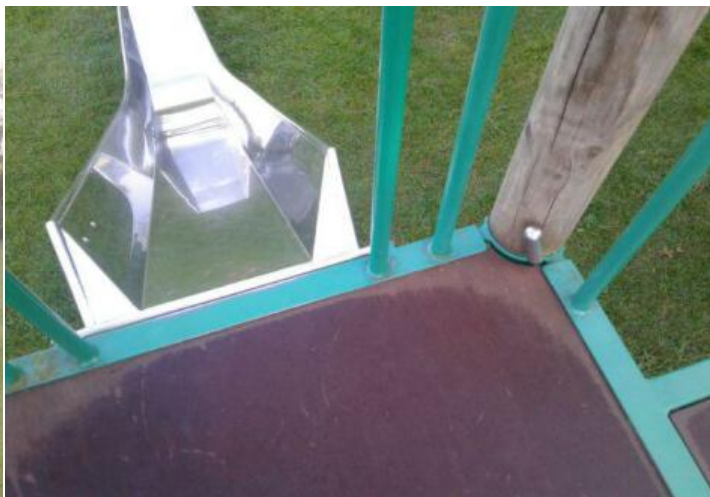
Finding: There is/are finger entrapment/s in the frame and the item fails to meet the requirements of BS EN 1176 Part 1 4.2.7.6 Entrapment of fingers

Action: Monitor - No remedial work recommended

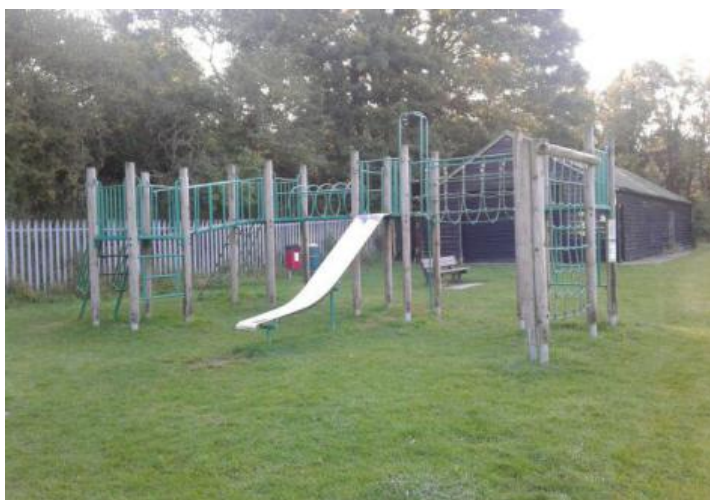
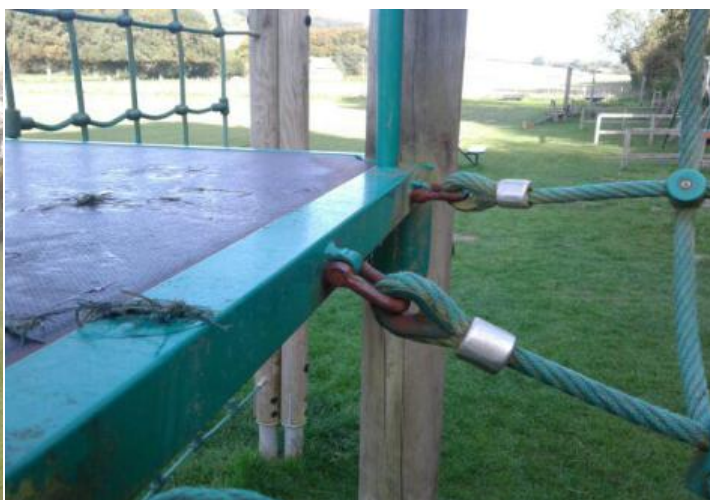
Finding: The shackle has some corrosion

Action: Monitor for any further deterioration and replace as required

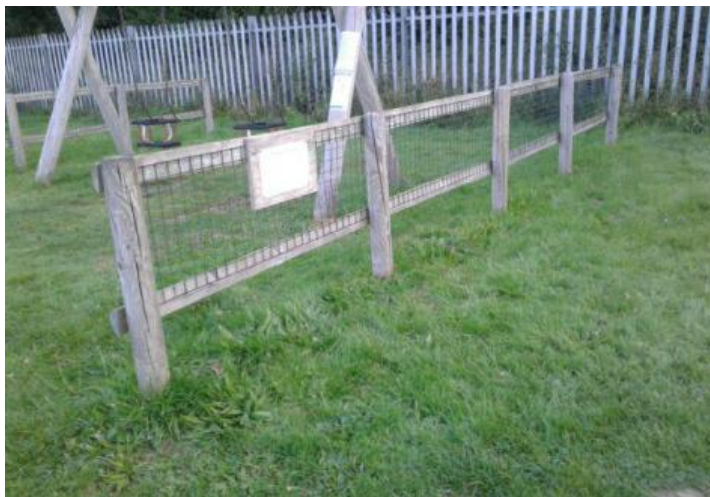
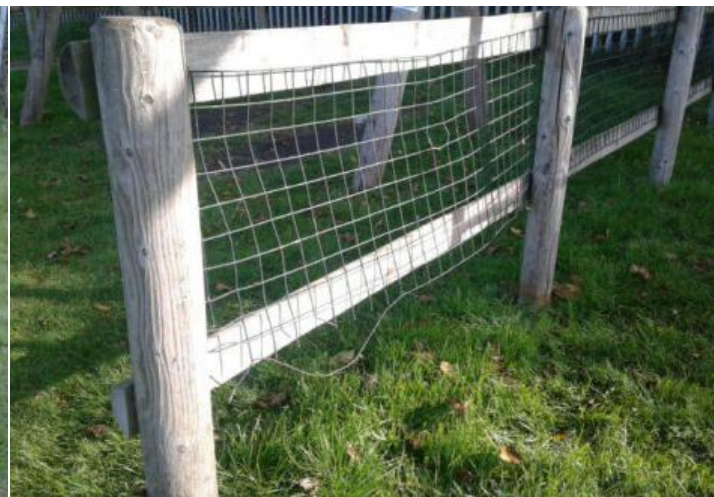
Finding: The mesh has been damaged and sharp wires are protruding
Action: Repair or replace the item

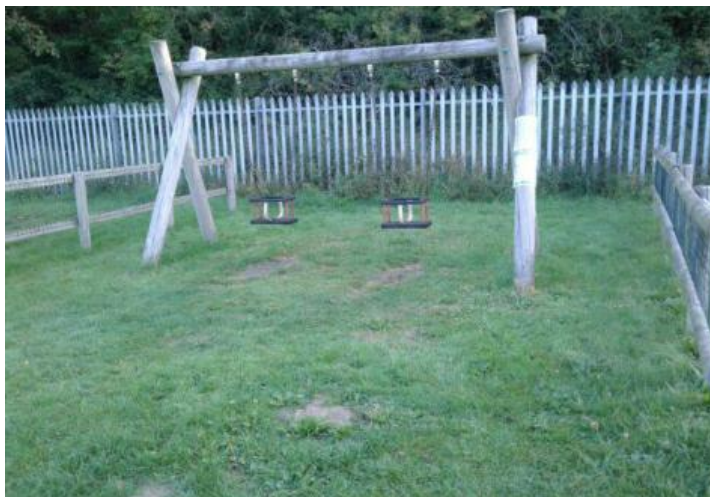
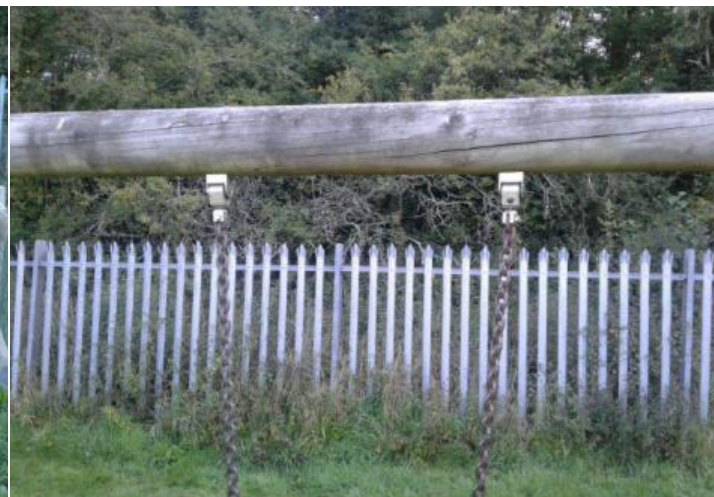
Finding: This design of swing joint has been known to fail on the weld connecting the joint to the threaded stud

Action: We would recommend that the joint be dismantled and checked on a regular basis or a Secondary Safety Device be fitted

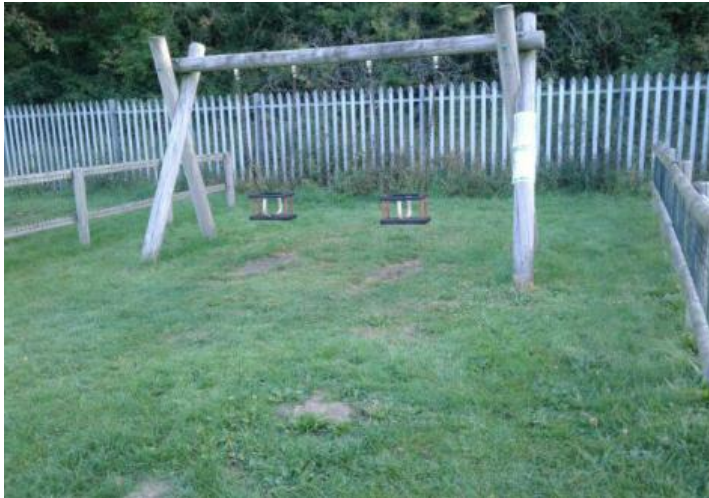
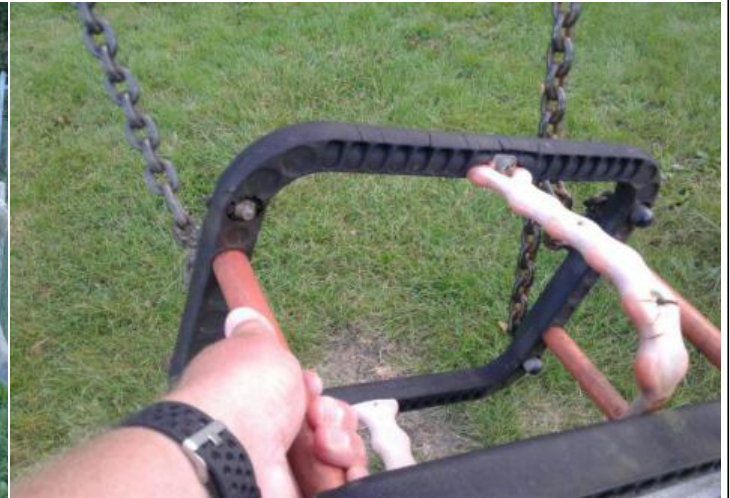
Finding: There are caps missing from the underside of the seats

Action: Replace missing caps under the seats

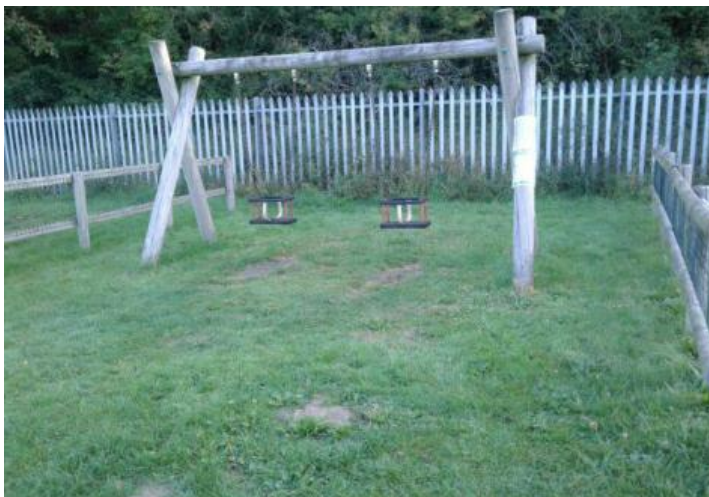
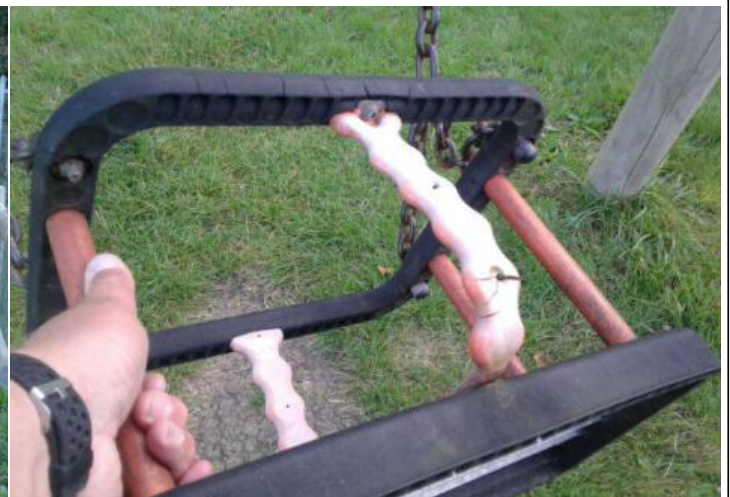
Finding: The swing seat frames are corroding

Action: Monitor for any further deterioration and replace as required

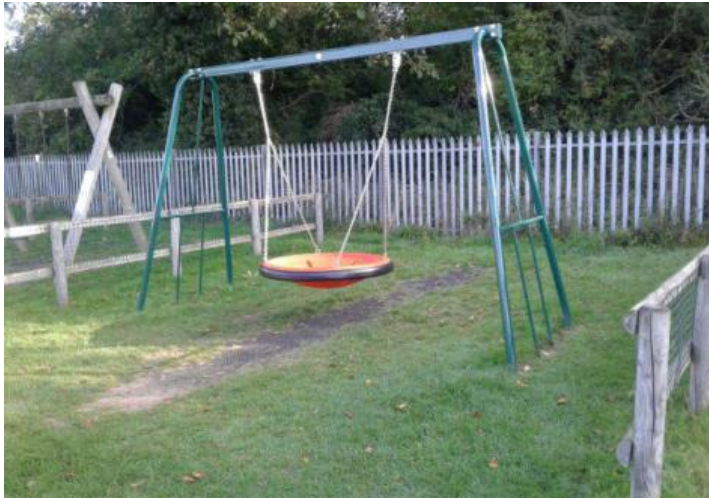
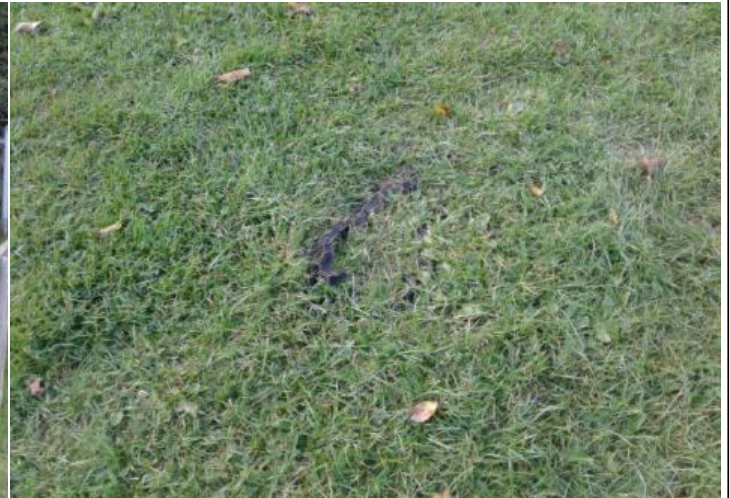
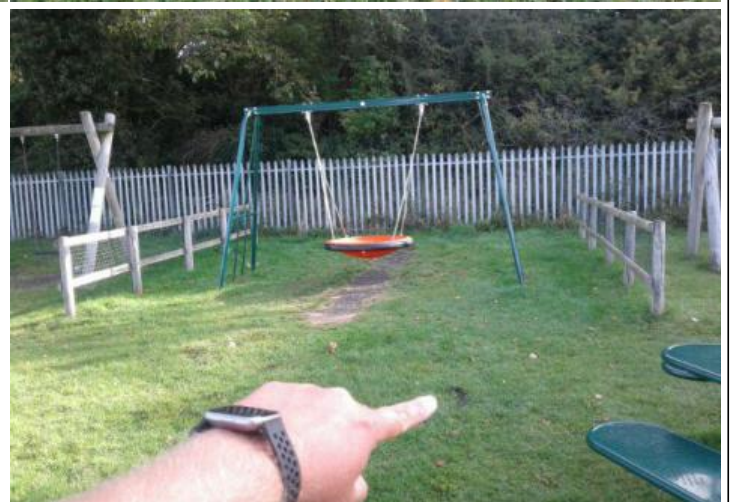
Finding: The surfacing around the item is damaged

Action: Repair the damaged areas of surfacing

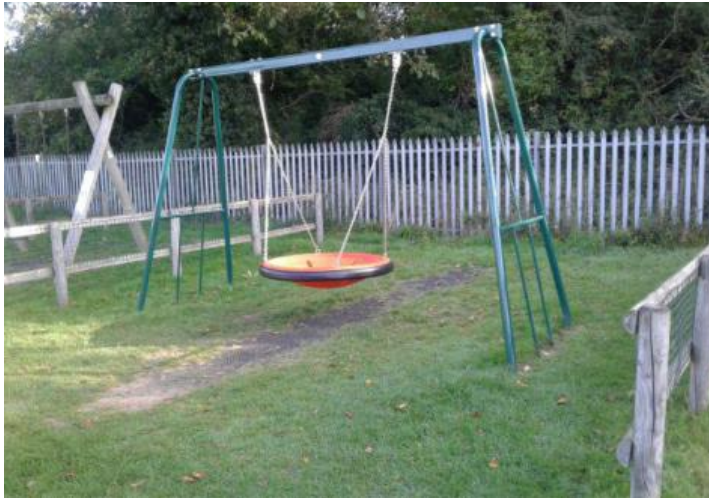
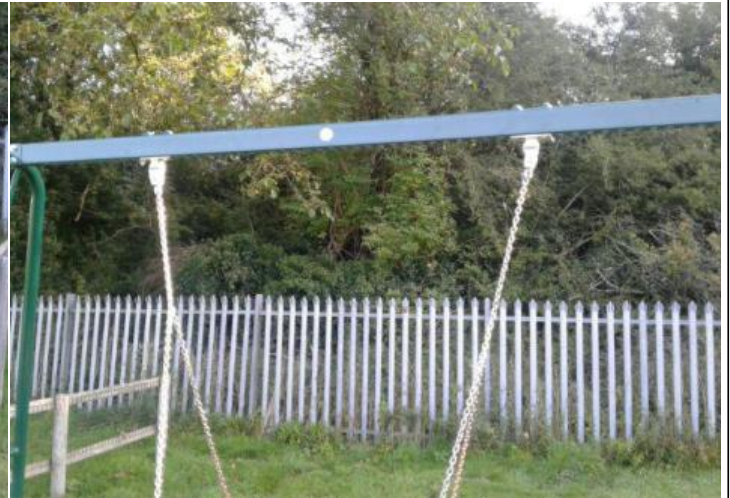
Finding: Swings of this design should have a secondary safety device fitted to prevent collapse of the seat in the event of a joint failure to meet the requirements of BS EN 1176 Part 2

Action: Consider providing a secondary safety device where possible

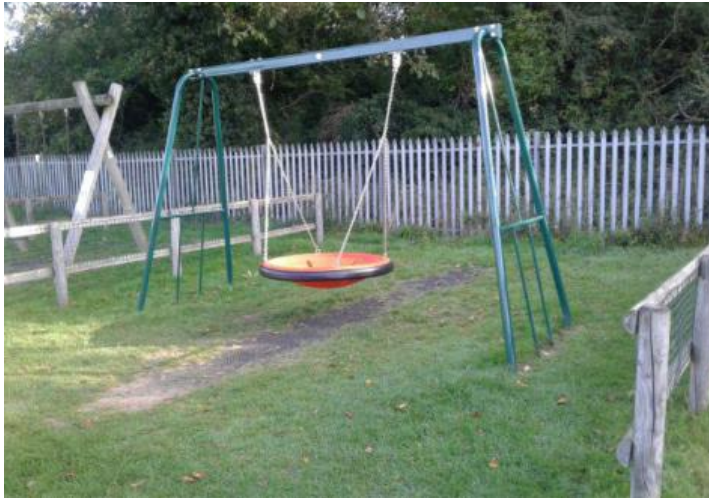
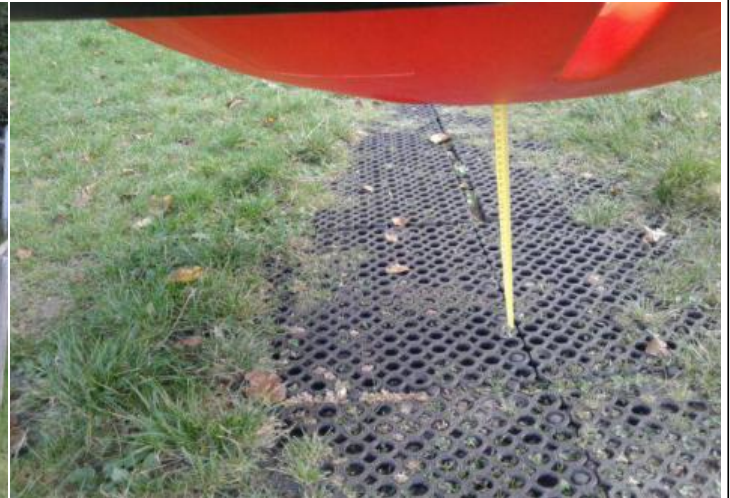
Finding: The seat clearance from finished surface level to the underside of the seat is too low when measured in its most onerous position and does not meet the requirements of BS EN 1176 Part 2

Action: Install seats to a minimum height of 400mm for Group Swing Seats

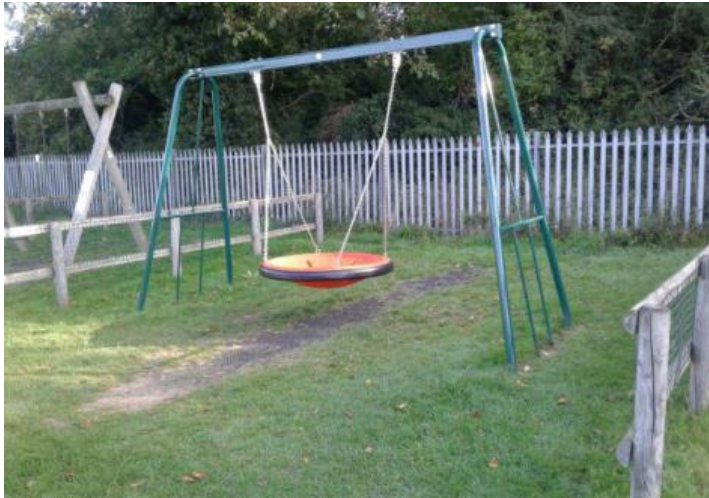
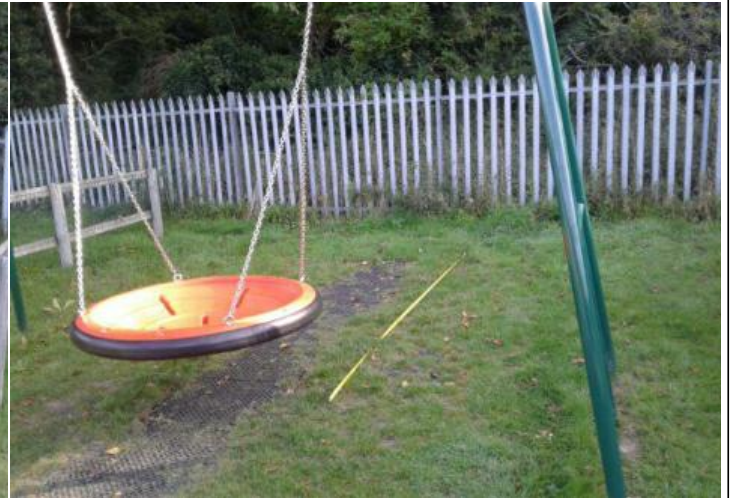
Finding: The edge of the impact area is less than 1.5m from the fence; BS EN 1176, Annexe A; we consider this to be a low risk finding and no remedial action is required

Action: Monitor - No remedial work recommended

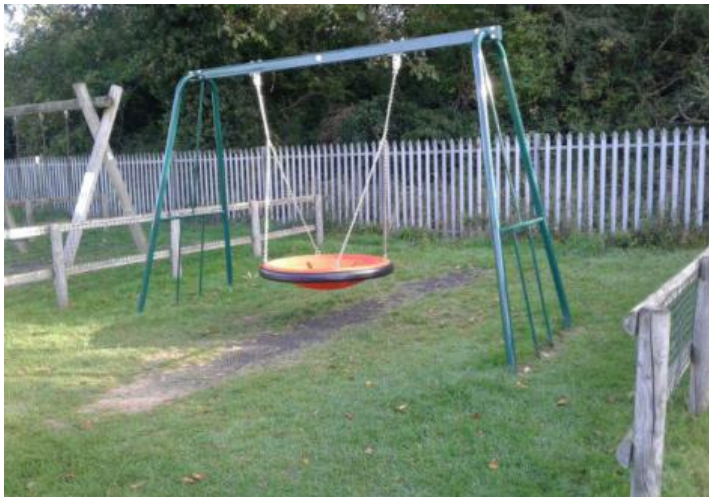
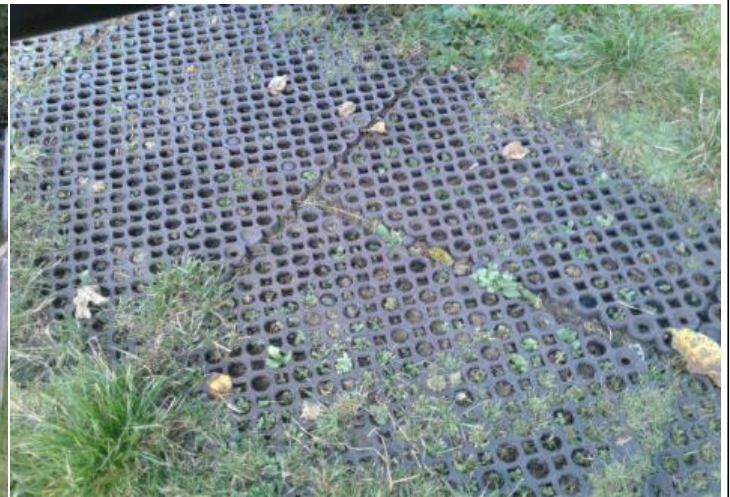
Finding: There are gaps opening between the grass mat tiles

Action: Reinstall surface

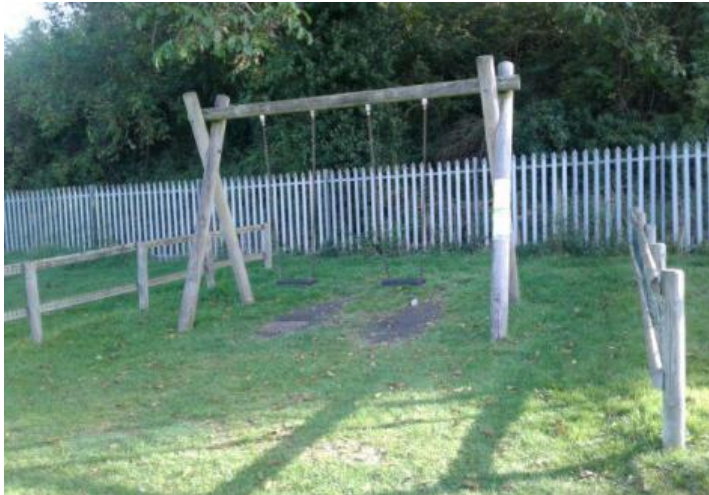
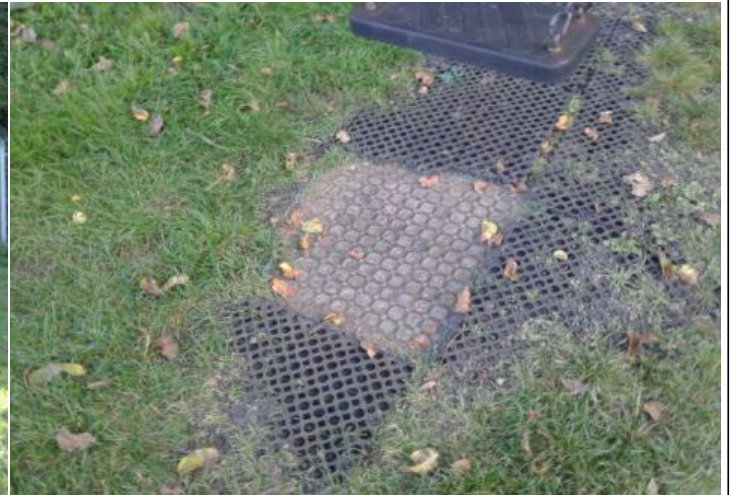
Finding: The surfacing around the item is damaged

Action: Repair the damaged areas of surfacing

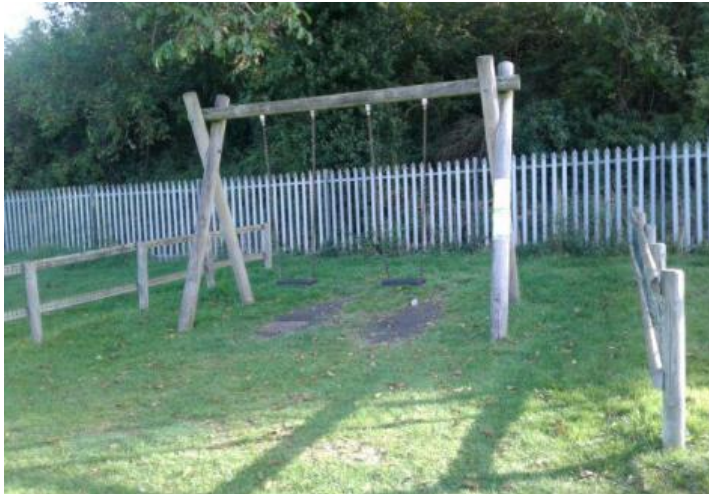
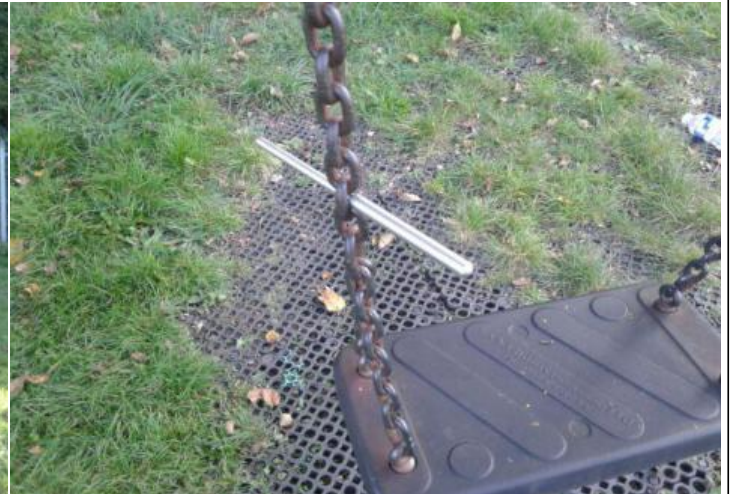
Finding: The connecting links are in excess of 8.6mm and less than 12mm and fail the requirements of BS EN 1176 Part 1; clause 4.2.13, Chains

Action: Monitor - No remedial work recommended

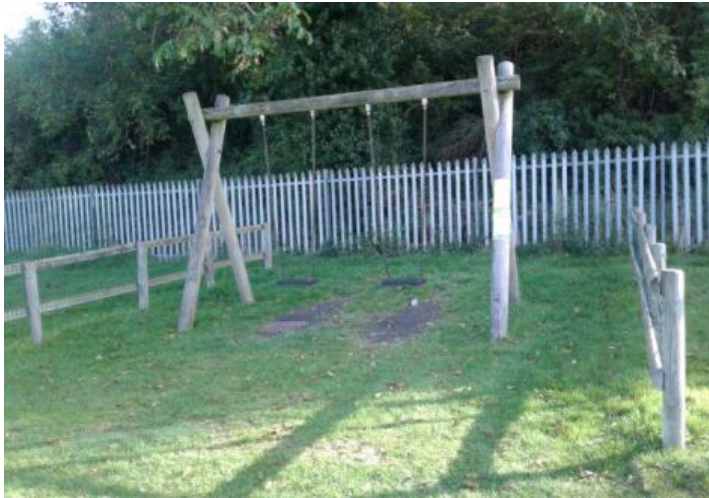
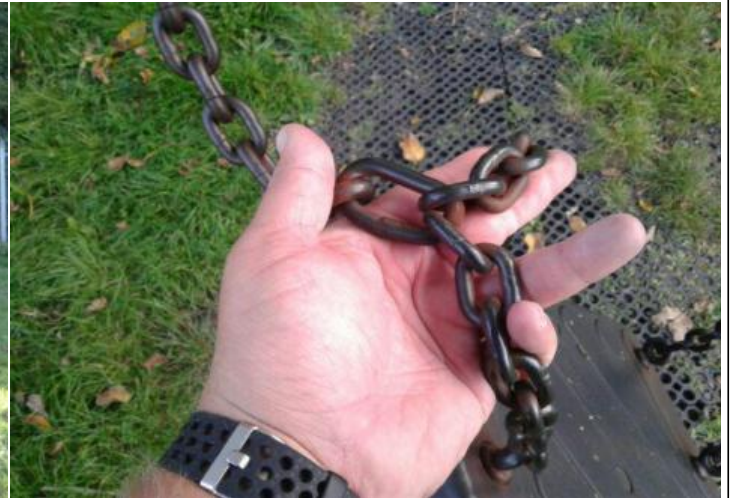
Finding: There is some notable evidence of chain wear

Action: Monitor for any further deterioration and replace when 40% worn

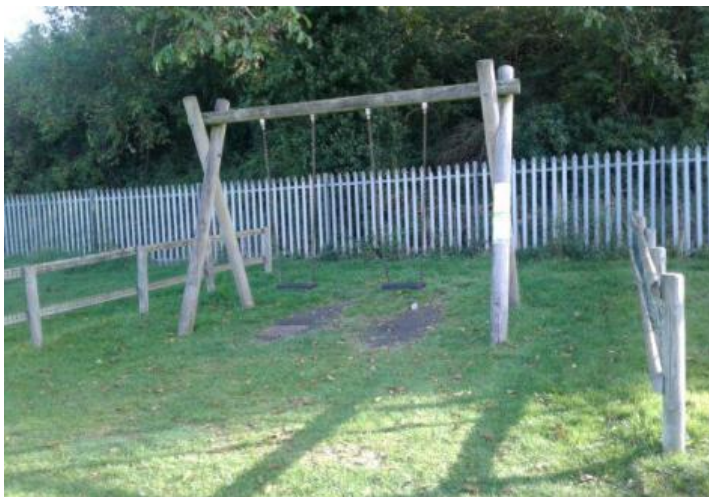
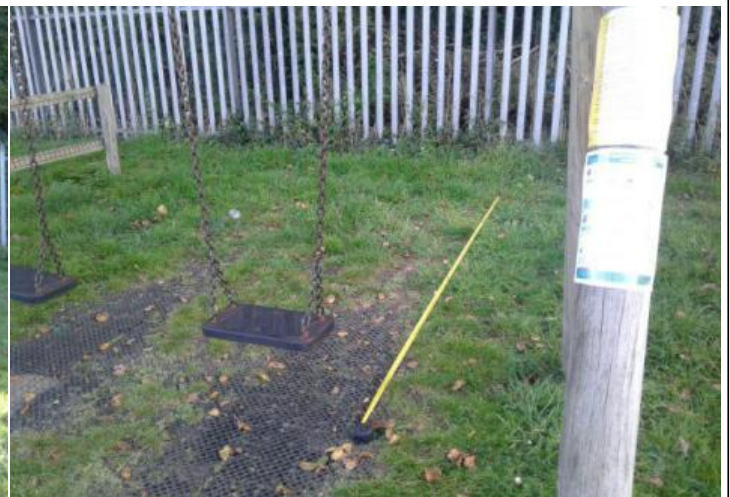
Finding: The edge of the impact area is less than 1.5m from the fence; BS EN 1176, Annexe A; we consider this to be a low risk finding and no remedial action is required

Action: Monitor - No remedial work recommended

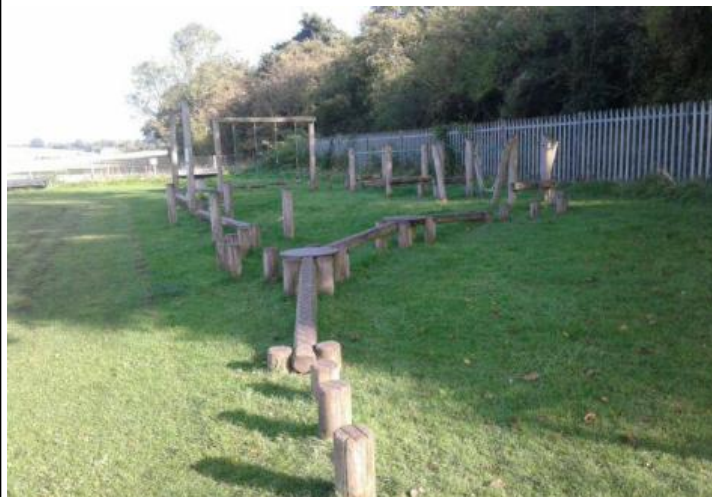
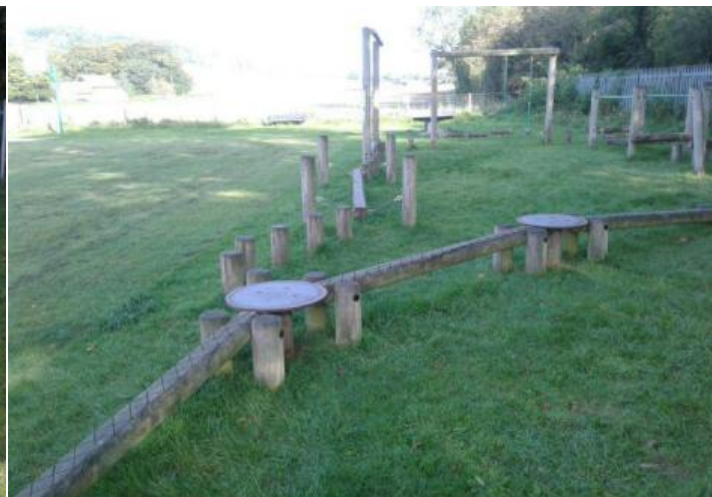
Finding: There is algae or moss on the surface of the equipment

Action: Clean and treat appropriately

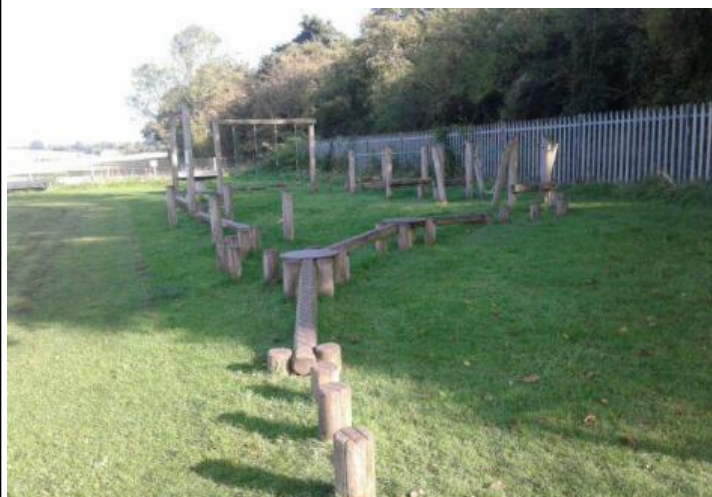
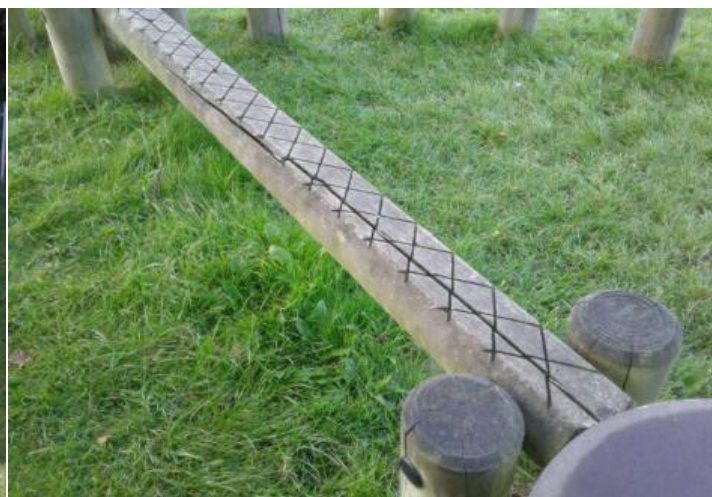
Finding: The timber has a number of splits/shakes or air cracks and this may affect the stability or allow water ingress which will accelerate the rotting process

Action: Monitor to ensure the splits do not cross through fixing points of the structure and/or cause any instability

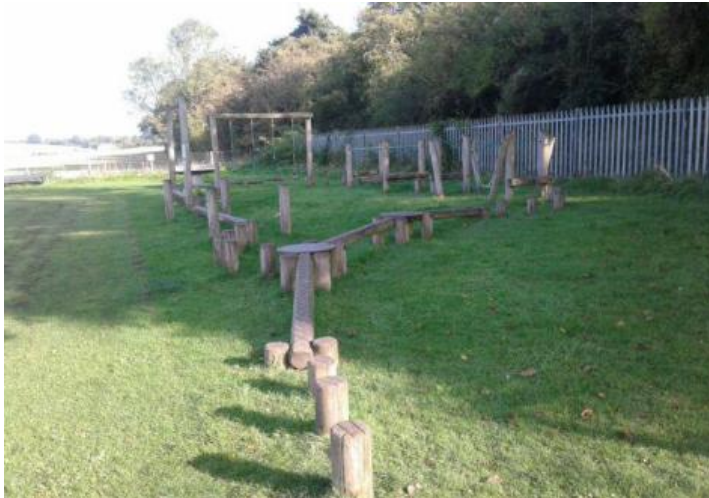
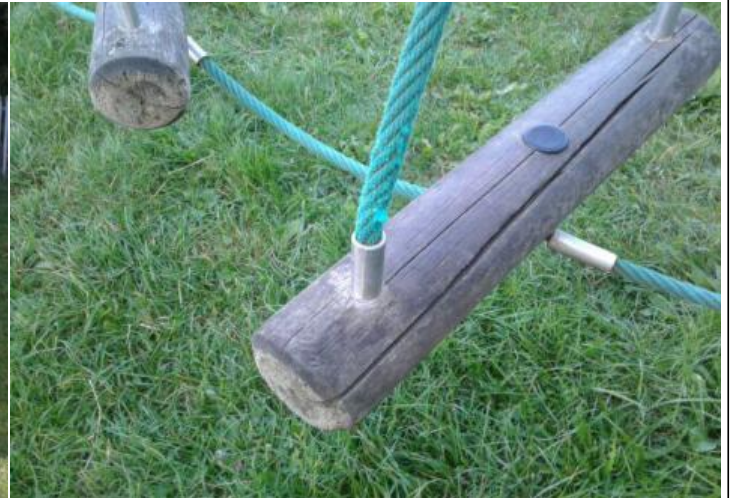
Finding: The ropes/nets are worn/damaged in places

Action: Monitor for any further deterioration and repair or replace as required

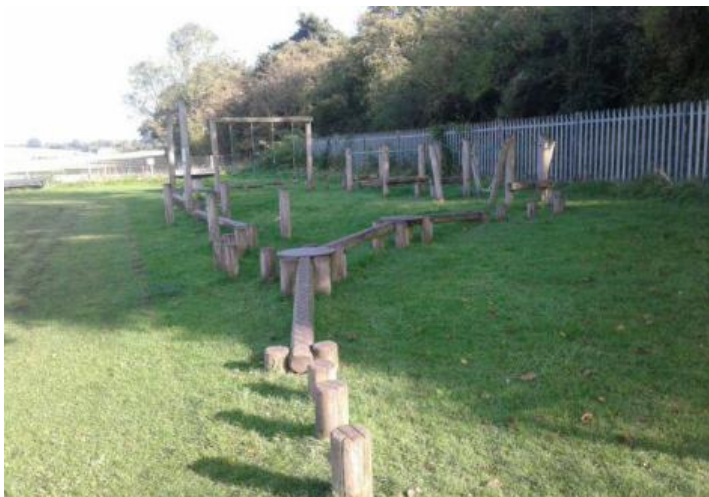
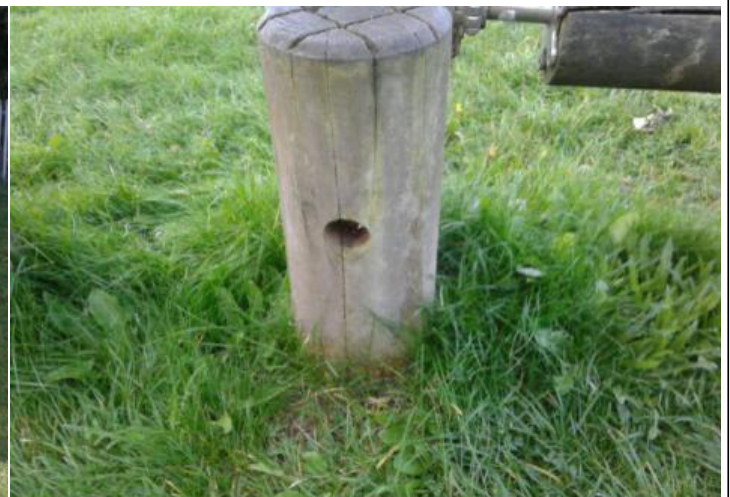
Finding: There is/are bolt cap covers missing or damaged on the item

Action: Replace missing or damaged bolt cap covers

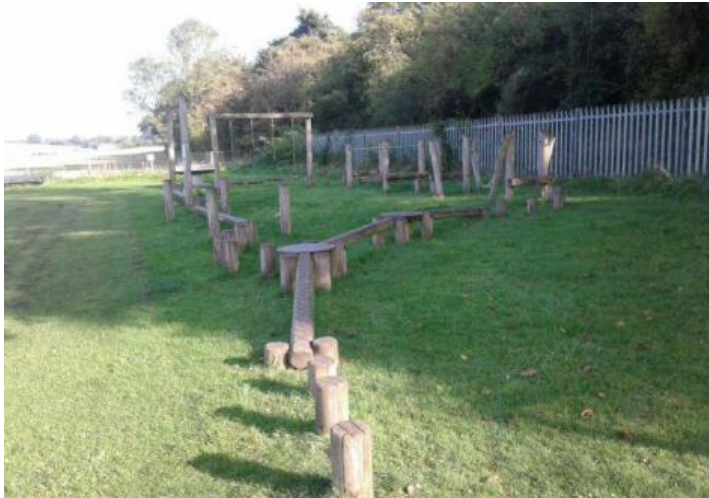
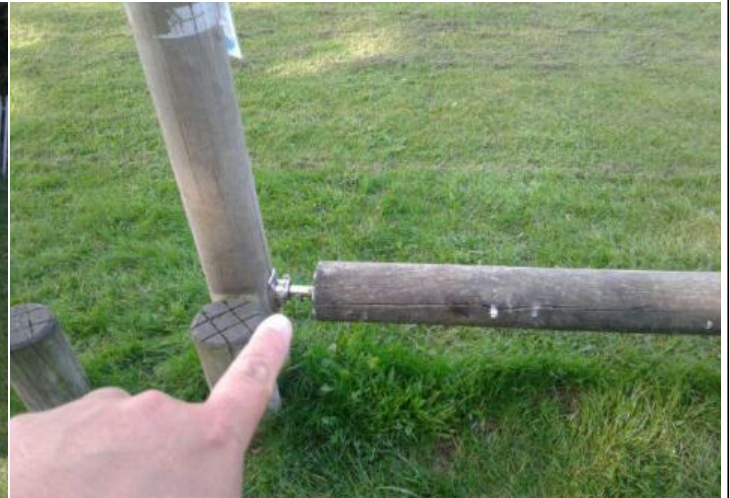
Finding: The bearing is not operating correctly

Action: Repair or replace the bearing as required

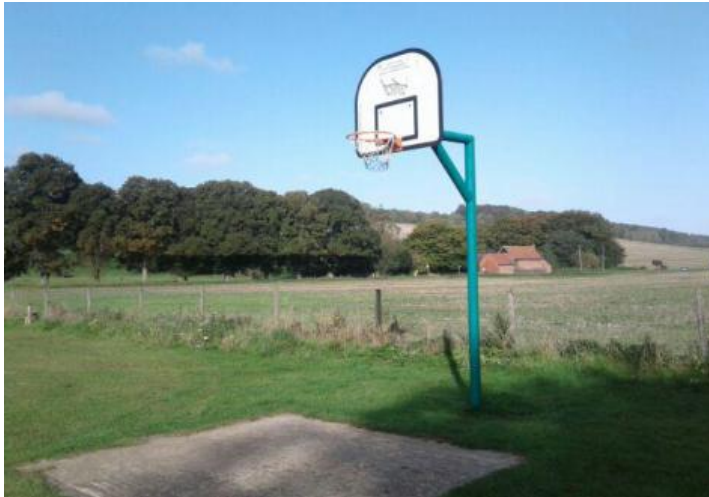
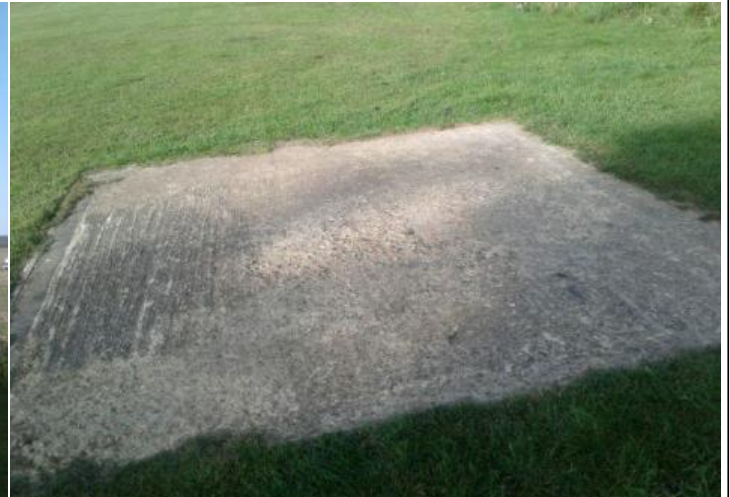
Finding: The concrete is showing signs of wear

Action: Monitor for any further deterioration and repair as required
