Transport for Buckinghamshire

West Wycombe High Street Footway Incursion

Feasibility Study Report

Date: 10th March 2022

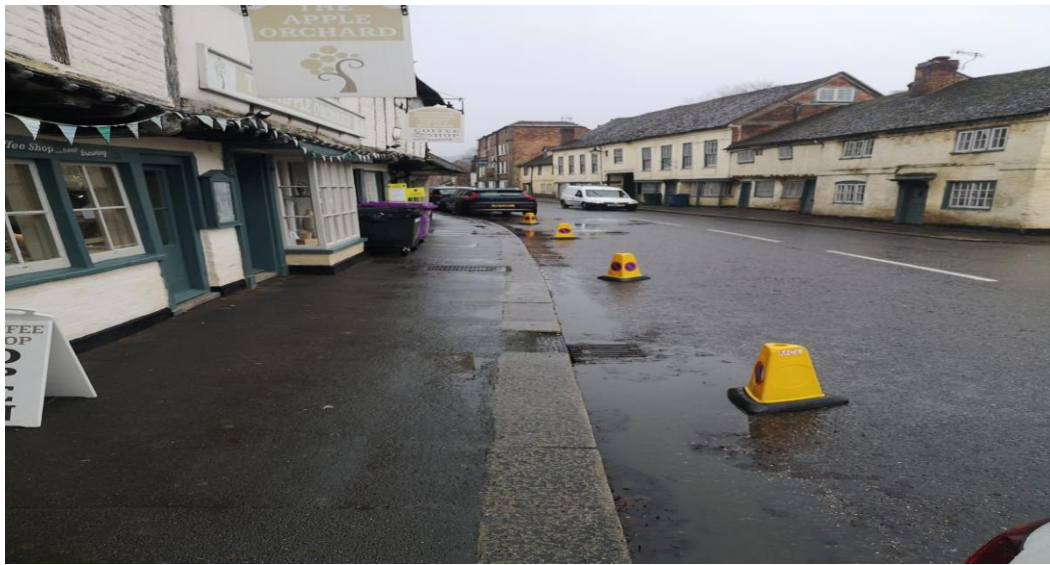
Figure 2: Temporary parking suspension between Nos. 58a & 59 High Street 'The Apple Orchard'.

- 4.3.1 The parking suspension was for 20 metres (4 parking spaces) as shown in Figure 2 overleaf. This parking suspension was effective from the 11th January 2022 – 25th January 2022.

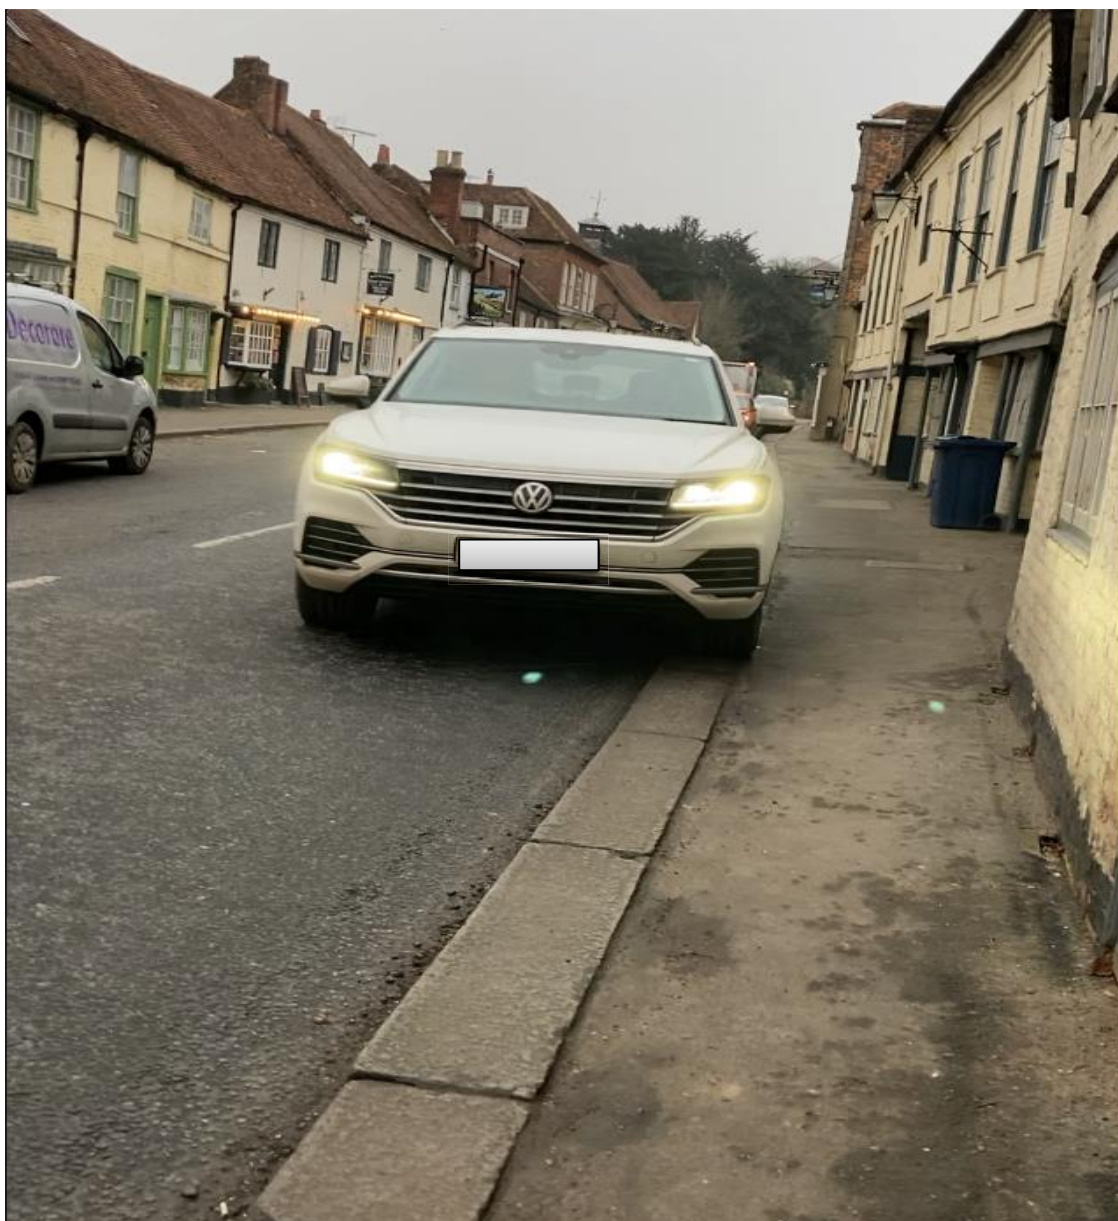
Figure 3: Footway Incursion incident on the 25th January 2022.

- 4.4.2.4 On the 25th January 2022 TfB attended site from 7:45 – 10:30. At 09:30 a motorist drove on the footway very close to the TfB observer. This motorist travelling eastbound was forced to take action to avoid colliding with an opposing vehicle due to the motorist being impatient and pushing their way through. Image of the vehicle driving on the footway is shown in Figure 3. The observer was uninjured as they were recording from a safe location.

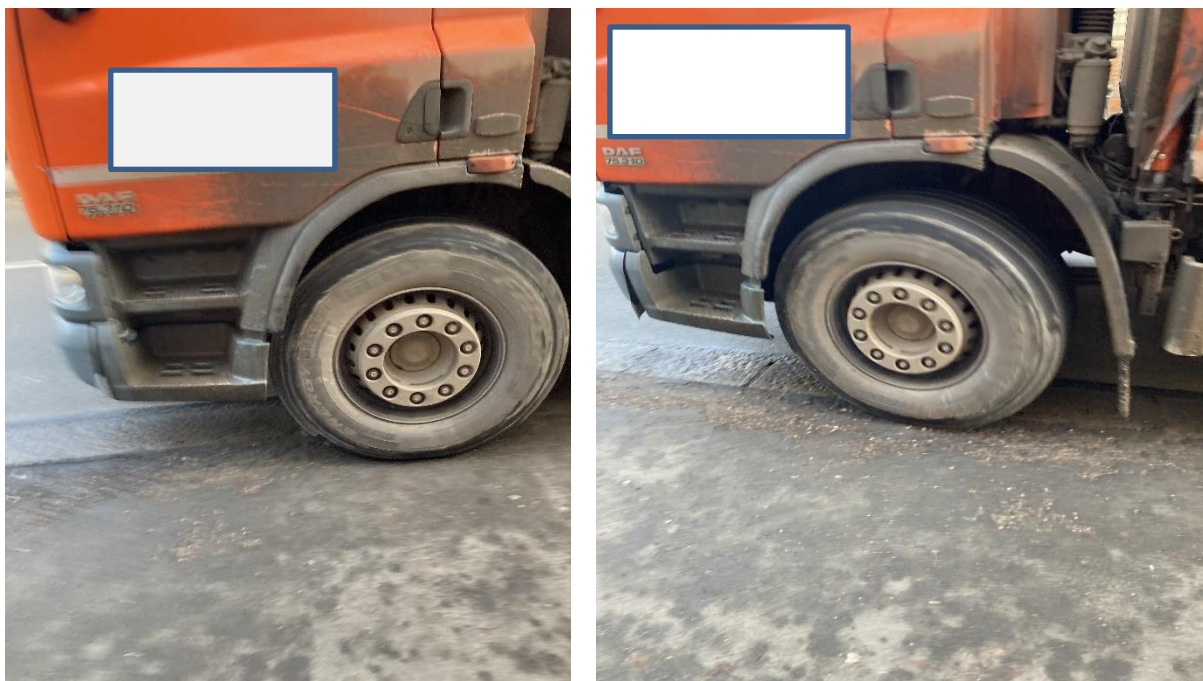
Figure 4: HGV Footway Incursion.

- 4.4.2.5 The site was assessed from the hours of 14:30 – 17:00 where the traffic was at its peak in the pm. The number of instances of footway incursions was also higher than anticipated, having three instances where some motorists drove on the footway. One instance was captured where an HGV driver drove on the footway to allow for a bus to pass, this image is shown in Figure 4.

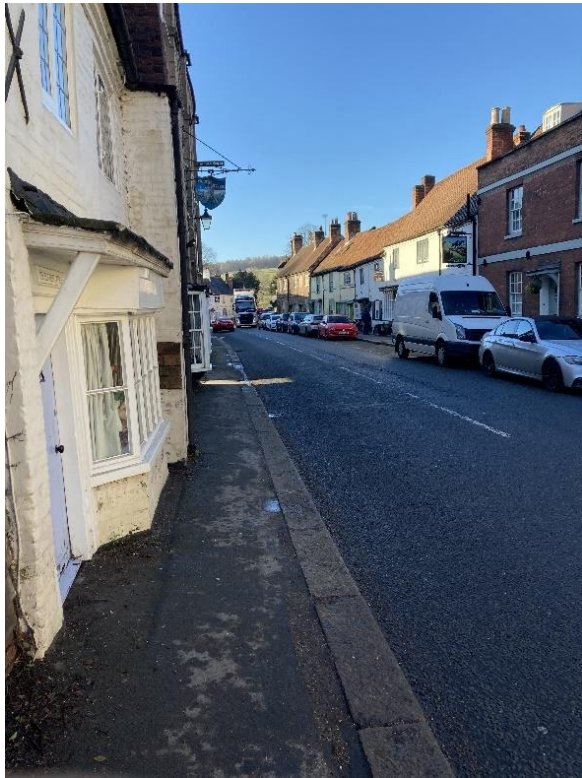
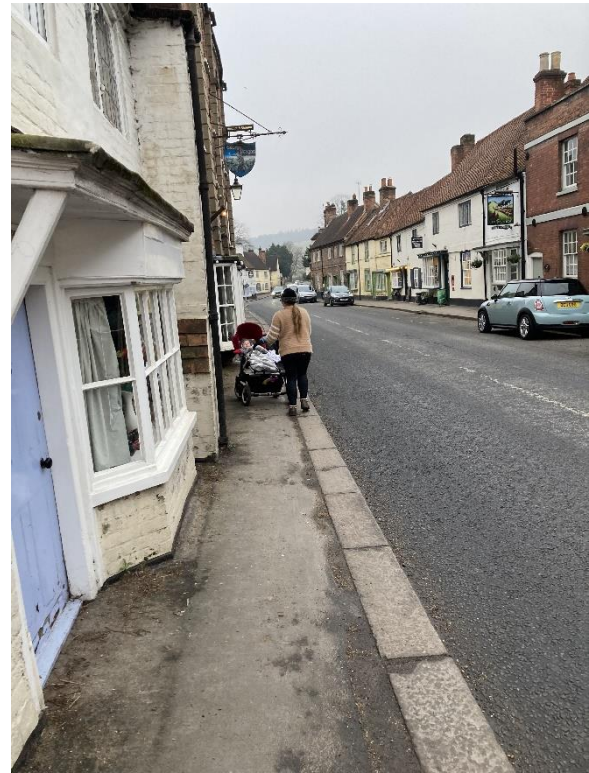
Figure 8: *Footway width not facilitating for pedestrian with a pram.*

- 7.5 TfB also noticed the footway being used by pedestrians travelling with a pram (some even with a double pram – See Figure 8). This not only shows a safety concern, it also shows the lack of formal crossing facilities in the area to facilitate for residents exiting their homes on that side of the footway.

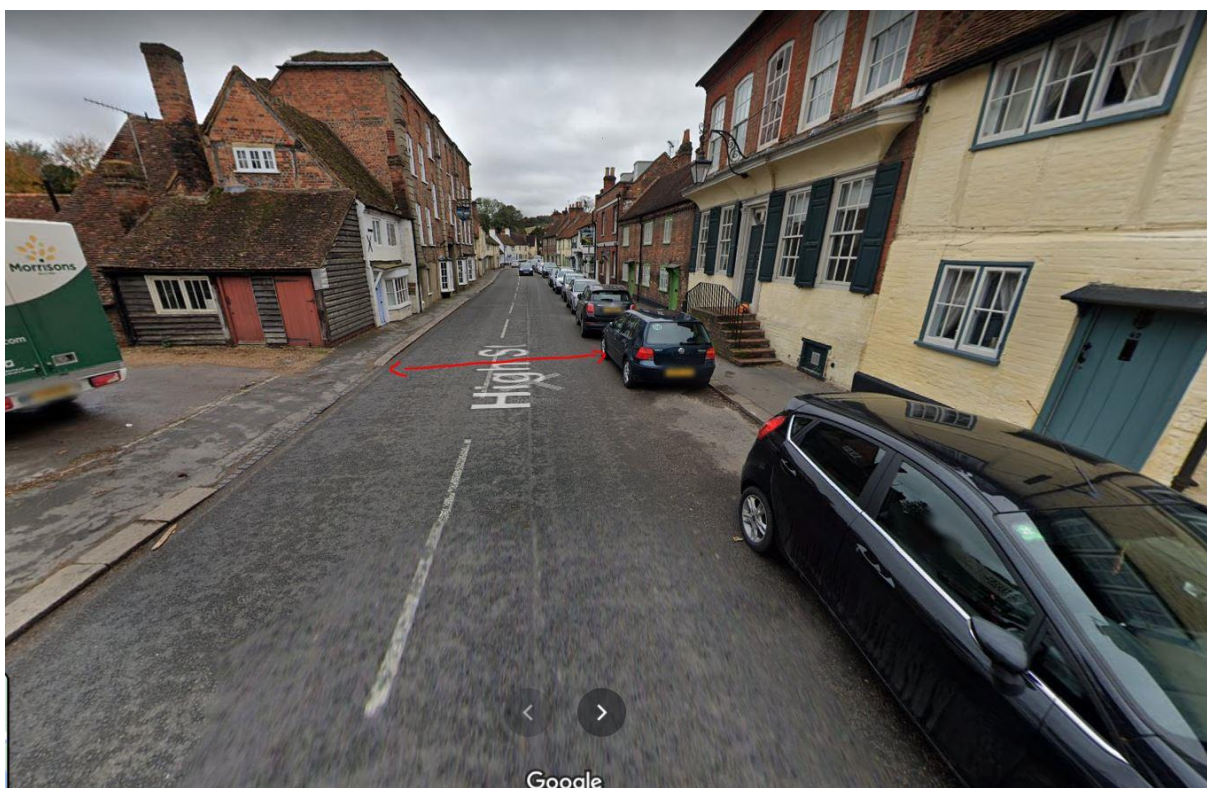
Figure 10.1: *Outside Steps House, limited carriageway width.*

- 9.11 Although removing the centre line may result in lower speeds, it does not eliminate the lack of carriageway width and visibility at the bend by the post office and outside the Steps House as shown in Figures 10.1 & 10.2.
