the **play inspection** company

Annual Inspection

The Pedestal Playing Field

Inspection Ref: 1188591

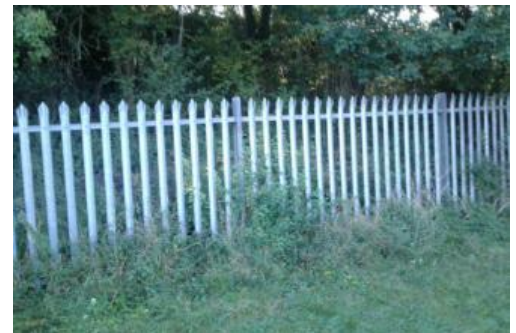
Finding 1

Item: Fence
Manufacturer: Not Identified
Surface Type: Grass
Item Quantity: 1
Equipment Compliance: N/A
Surface Area Compliance: N/A

This item is satisfactory - no work required -

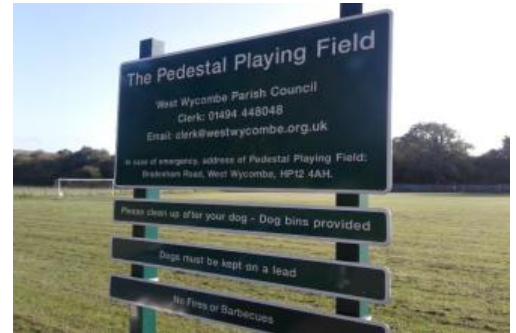
Finding 1

Item: Sign
Manufacturer: Owner/Operator
Surface Type: N/A
Item Quantity: 1
Equipment Compliance: N/A
Surface Area Compliance: N/A

This item is satisfactory - no work required -

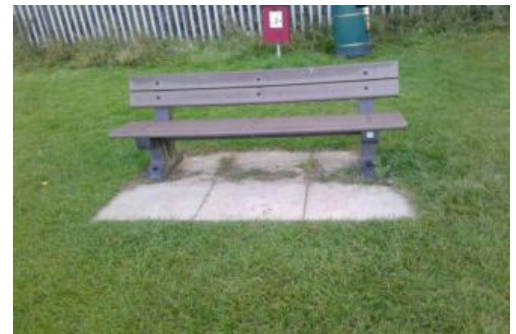
Finding 1

Item: Bench
Manufacturer: Owner/Operator
Surface Type: Paving Slabs
Item Quantity: 2
Equipment Compliance: N/A
Surface Area Compliance: N/A

This item is satisfactory - no work required -

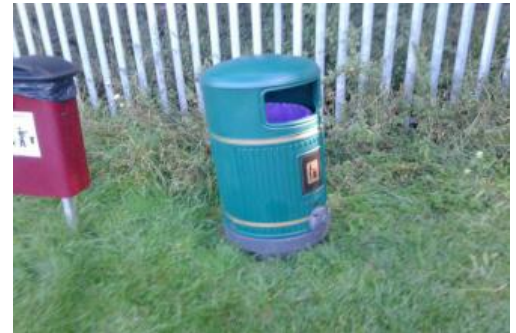
Finding 1

Item: Litter Bin
Manufacturer: Owner/Operator
Surface Type: Grass
Item Quantity: 1
Equipment Compliance: N/A
Surface Area Compliance: N/A

This item is satisfactory - no work required -

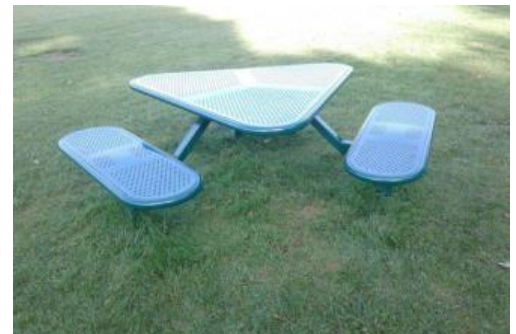
Finding 1

Item: Picnic Table
Manufacturer: Not Identified
Surface Type: Grass
Item Quantity: 1
Equipment Compliance: N/A
Surface Area Compliance: N/A

This item is satisfactory - no work required -

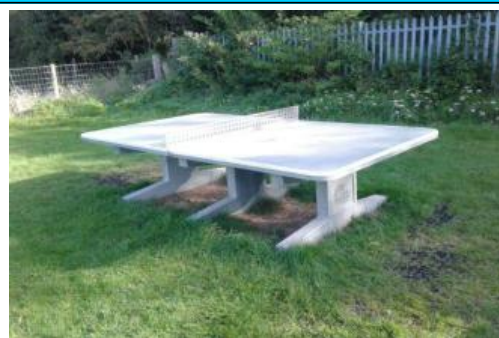
Finding 1

Item: Table Tennis
Manufacturer: Not Identified
Surface Type: Grass Matrix Tiles
Item Quantity: 1
Equipment Compliance: N/A
Surface Area Compliance: N/A

This item is satisfactory - no work required -
